**Looking for the basis of Nan Madol's  
platforms: coring and test-pit excavations  
in some channels and structures of  
Pohnpei's World Heritage Property  
(Federated States of Micronesia) (23<sup>rd</sup>  
January-3<sup>rd</sup> February 2018)**

**SAND, Christophe  
LEBEHN, Jason  
SILBANUZ, Semens  
WALTER, Peter Salapat  
BARNABAS, Jason  
HEBEL, Motoichi**

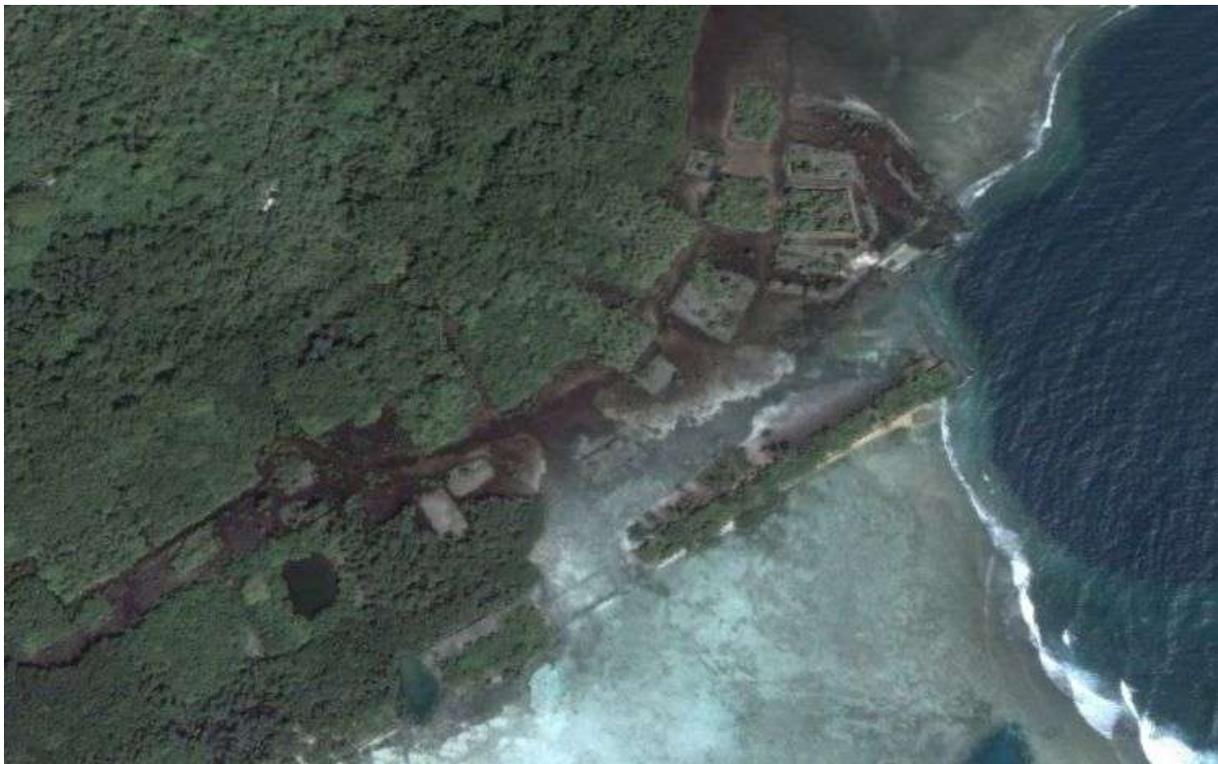
Figure 3. Aerial photograph of Nan Madol at the south-eastern boundary of Temwen Island, showing the overgrowth of the channels at the end of the 1990s and some of the square raised platforms. Vegetation cover has significantly increased over the last 20 years.

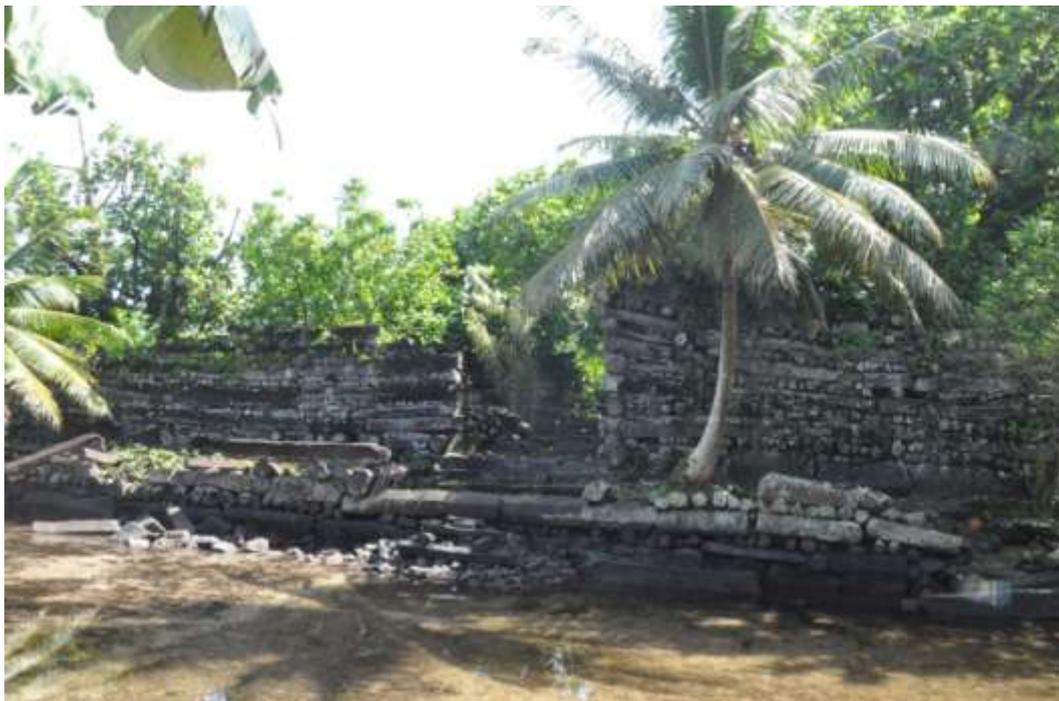
Figure 6. The same location as figure 5 taken in January 2018 at near low tide (photo C. Sand).

Information of the former height of the fill can also be gained from old photographs. The earliest photos used for the present study are from Kubary's collection, stored in Holland<sup>1</sup>. Comparing the 1870s photo of the entrance of Nan Dawas (fig. 5) with the same location today (fig. 6), allows to show that there does not appear to have been a significant change in fill height since the second half of the 19<sup>th</sup> century.

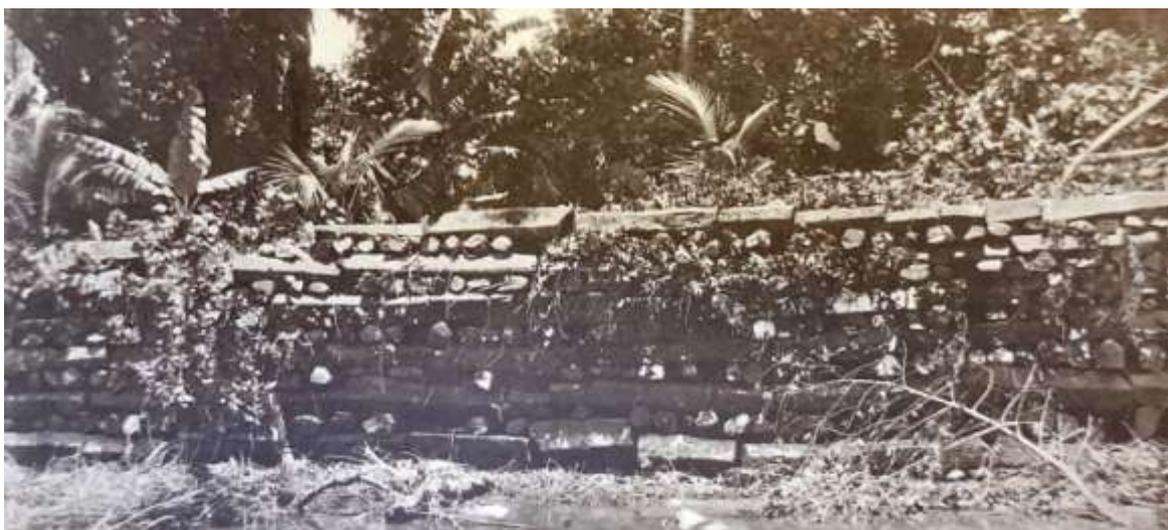
Figure 7. Pankedira's southeastern retaining wall, showing the mud-flat at low tide (in Hambruch 1936).

Photos taken in 1910 by P. Hambruch during the German *Südsee Expedition* show the same general pattern of a near-dry channels when close to low tide (fig. 7). This can also be concluded by looking at informative photographs taken from the top of Nan Dawas's western wall during the 1963 archaeological expedition of B. Meggers and C. Evans to Nan Madol, under the auspices of the Smithsonian Institution<sup>2</sup>. On a picture looking towards the channel between Dau platform (n°111) and Kohnderek platform (n°115) can clearly be identified the presence of white crab-hole mounds on the dry sand, which is covered by dark sea-grass (fig.

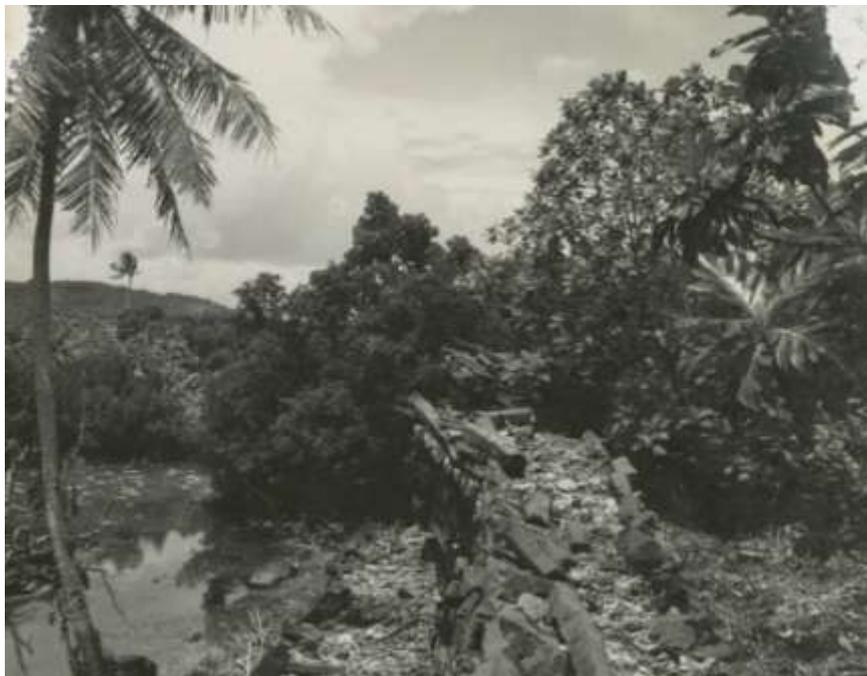
Figure 8. Photograph showing the western wall of Nan Dawas and the open channel between platforms Dau and Kohnderek at low tide (photograph MC7317, B. Meggers and C. Evans collection 1963, Smithsonian Institution, Washington DC; courtesy J. Peterson).

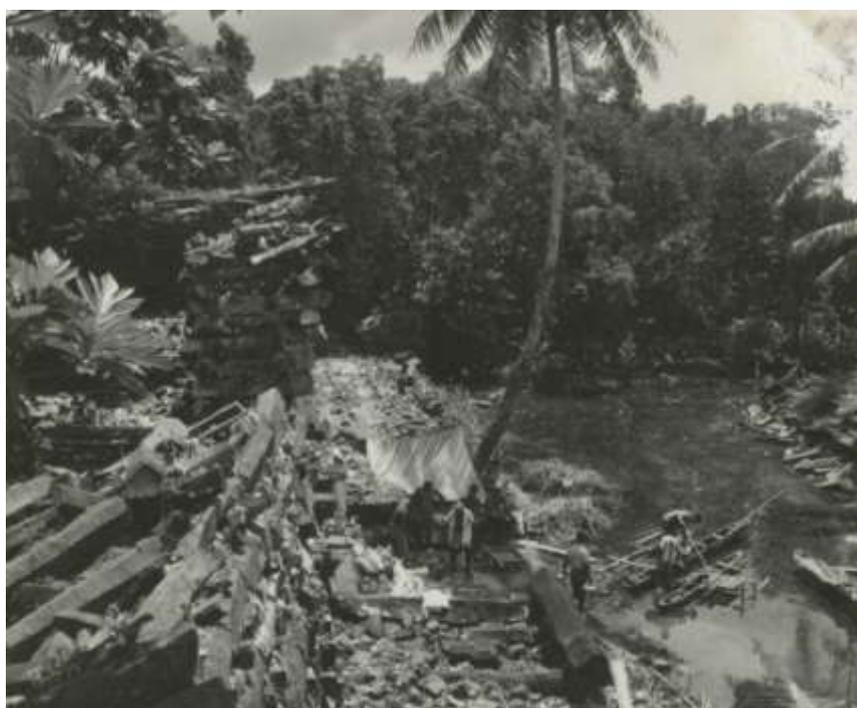
Figure 9. Photograph of the western wall of Nan Dawas, showing the channel facing Dau platform 111 at low tide (photograph MC7318, B. Meggers and C. Evans collection 1963, Smithsonian Institution, Washington DC; courtesy J. Peterson).

8). A picture looking towards the south-west angle of Nan Dawas, shows someone beside a traditional canoe in the channel, with water only up to his calf (fig. 9). In the main channel of the southern half of Nan Madol facing platforms like Pankedira (n°33), photographs taken at low tide of retaining walls, show clearly the presence of a drying mud sediment (fig. 10).

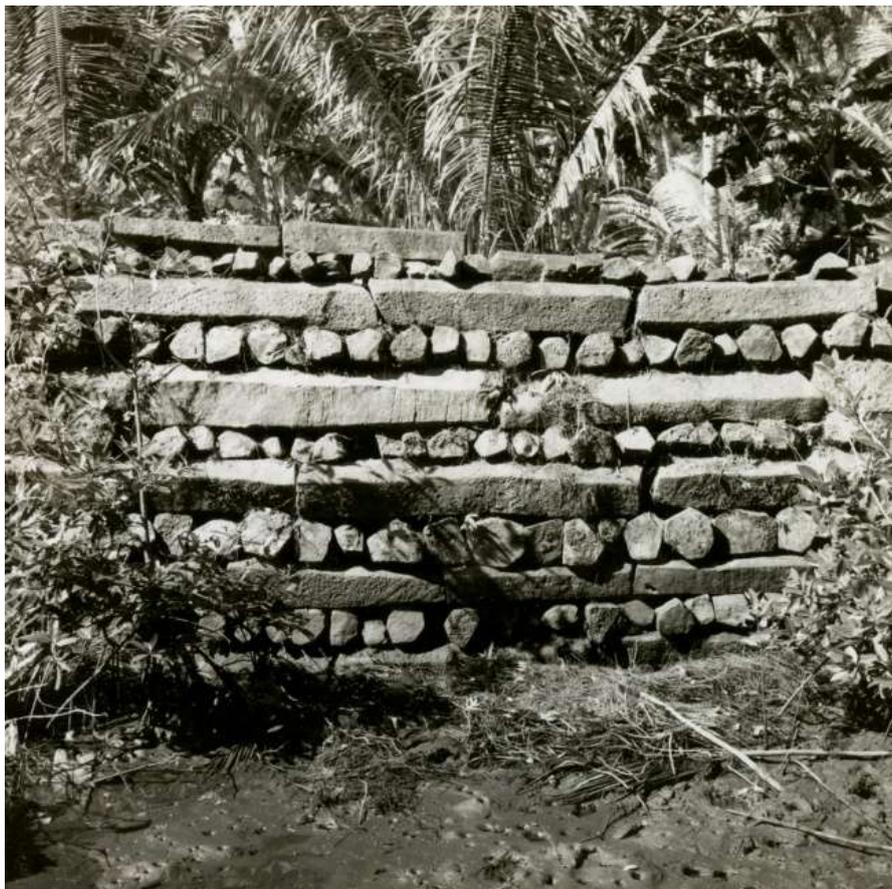
Figure 10. Retaining wall of a platform (possibly Pankedira, n°33) showing overgrowth of mangrove and the drying mud visible at low tide (photograph MC7150, B. Meggers and C. Evans collection 1963, Smithsonian Institution, Washington DC; courtesy J. Peterson).

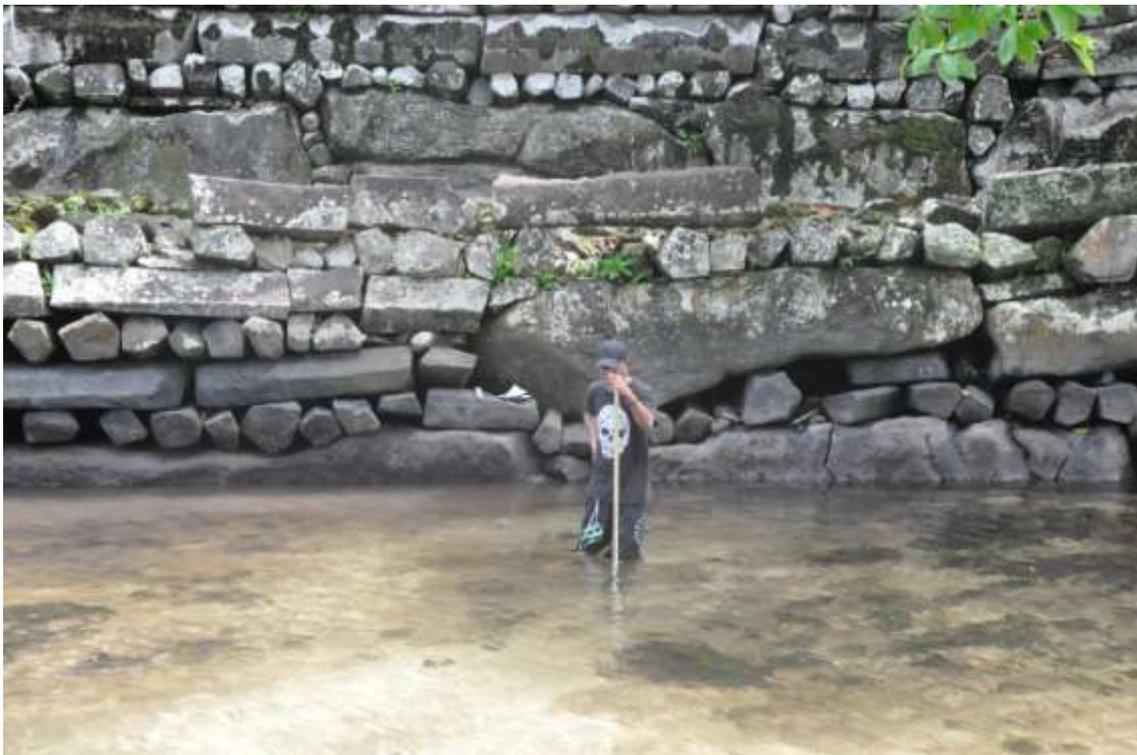
Figure 12. Jason Lebehn starting the coring in front of Nan Dawas (EX. 1).

Core positioned 3 meters away from the western retaining wall of Nan Dawas (platform 113), on the southern half, about 13m from the last *in-situ* stone visible at the southwest corner (fig. 12). The sandy deposit turned out to be very compact and the coring device had real difficulty being drilled in the sediment. Excavation 6 has shown that the fill is mainly composed of stone/coral pebbles and shells, preventing any use of a coring device. It was though decided to abandon the coring after about 30cm.

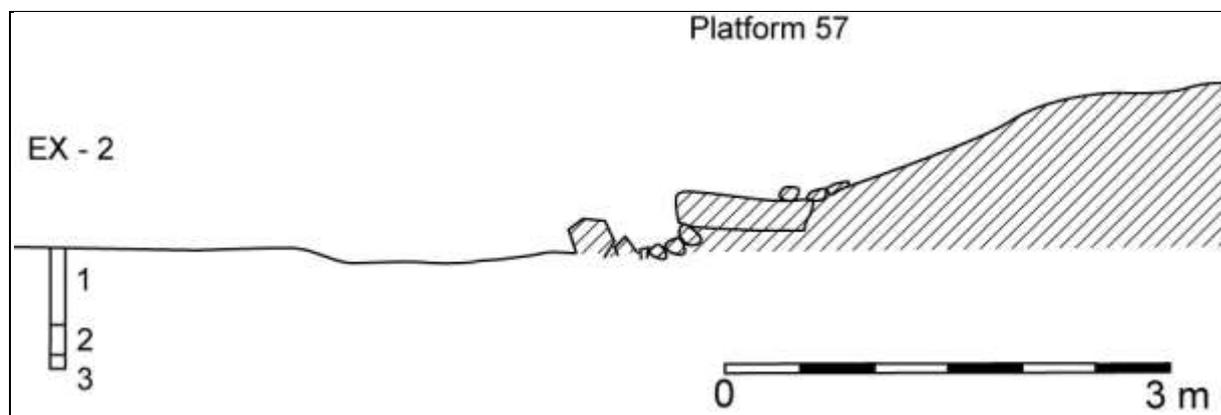
Figure 13. Profile of excavation 2 beside platform 57, with the 3 different stratigraphic levels identified through coring.

Core positioned about 4 meters away from the south-western wall of platform 57 (Peidoh), near the southern limit of the collapsed retaining wall. The following stratigraphy was observed (fig. 13):

- 0-50cm (Level 1). Loose superficial soil of dark brown color with roots.
- 50-75cm (Level 2). Mix of clear brown soil and sand, with a fill of small shells and small stone/coral pebbles.
- 75cm- + (Level 3). Start of a harder gravel layer mixed in brown soil (sample collected). The coring was stopped à 85cm.

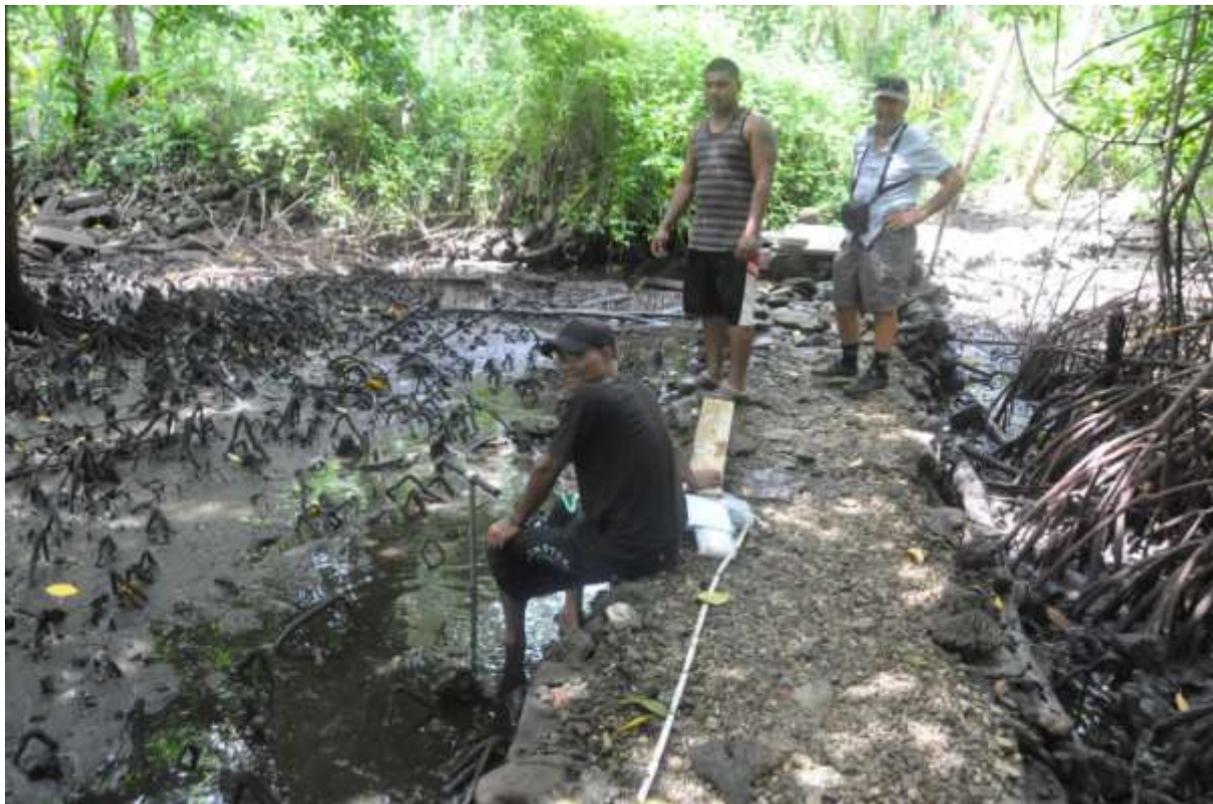
Figure 14. Location of excavation 3 beside the modern walkway, looking towards platform 57. The dry mud of the low tide is clearly visible.

Core positioned in between platforms 57 (Peidoh) and 86 (Sapwenpei), at equal 8 meters distance from each collapsed wall limit, and 60cm from the south-western edge of the present artificial raised causeway allowing tourist access (fig. 14). The following stratigraphy was observed (fig. 15):

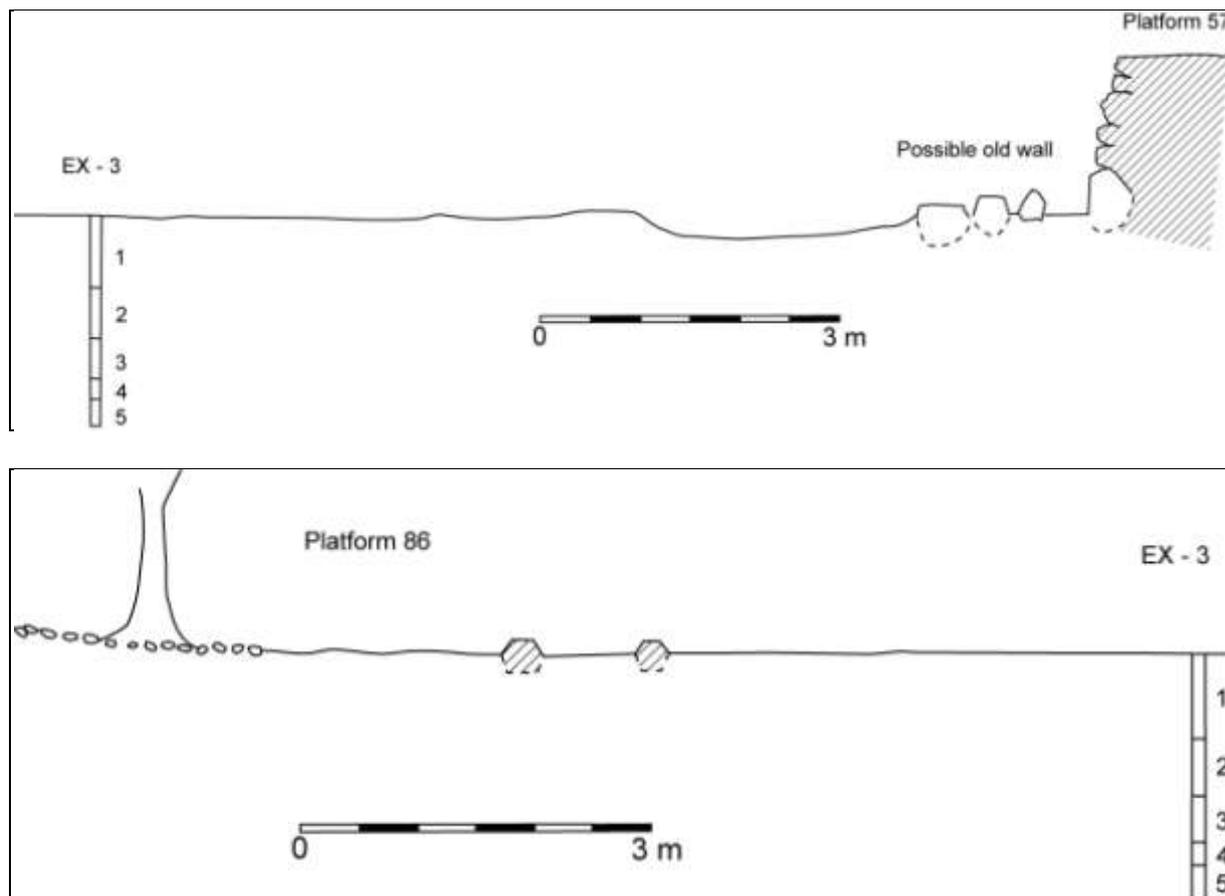
Figure 15. Profile of the deep stratigraphy identified in excavation 3, positioned between platforms 57 and 86.

- 0-70cm (Level 1). Fairly compact clayish red-brown soil, resulting apparently from the accumulation of decomposing tree leaves (sample collected).
- 70-120cm (Level 2). Loose dark brown soil texture, with no other apparent fill.
- 120-160cm (Level 3). Dark brown soil with small pebbles and some very fragmented shells (sample collected).
- 160-180cm (Level 4). Light brown soil and silt/sand lenses, with fragmented shells (sample collected).
- 180cm-+ (Level 5). Gray sandy fill, with presence of micro-strata, and some shell fragments (sample collected) (see fig. 46). This has tentatively been interpreted as the basis of the original channel. A black sample of possible wood flake has been collected for C14 dating. The core reached 210cm before being stopped.

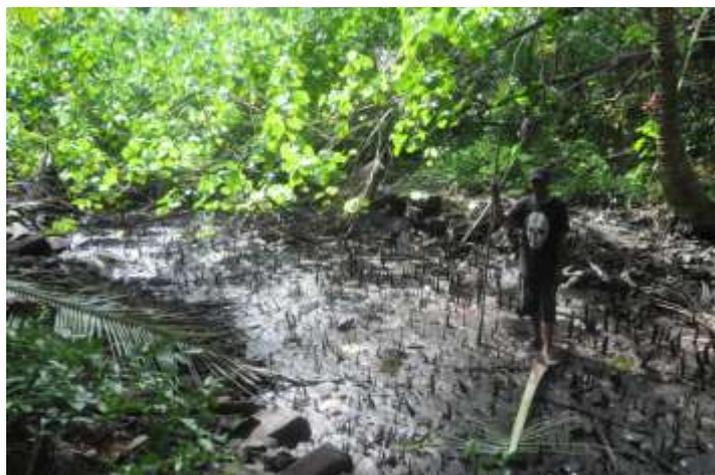
Figure 16. The auger stuck on pebbles and rocks, at the beginning of the coring of excavation 4 in the small channel between platforms 84 (right) and 99 (left). Note the mud surface at low tide.

Core positioned in the center of the small channel separating platforms 84 (Usenpei) and 99 (Rasalap), about 6 meters from the eastern corner of platform 84 (fig. 16). A series of cores along a 100cm transept were all stopped at about 50cm depth by a stony fill that was impossible to overpass.

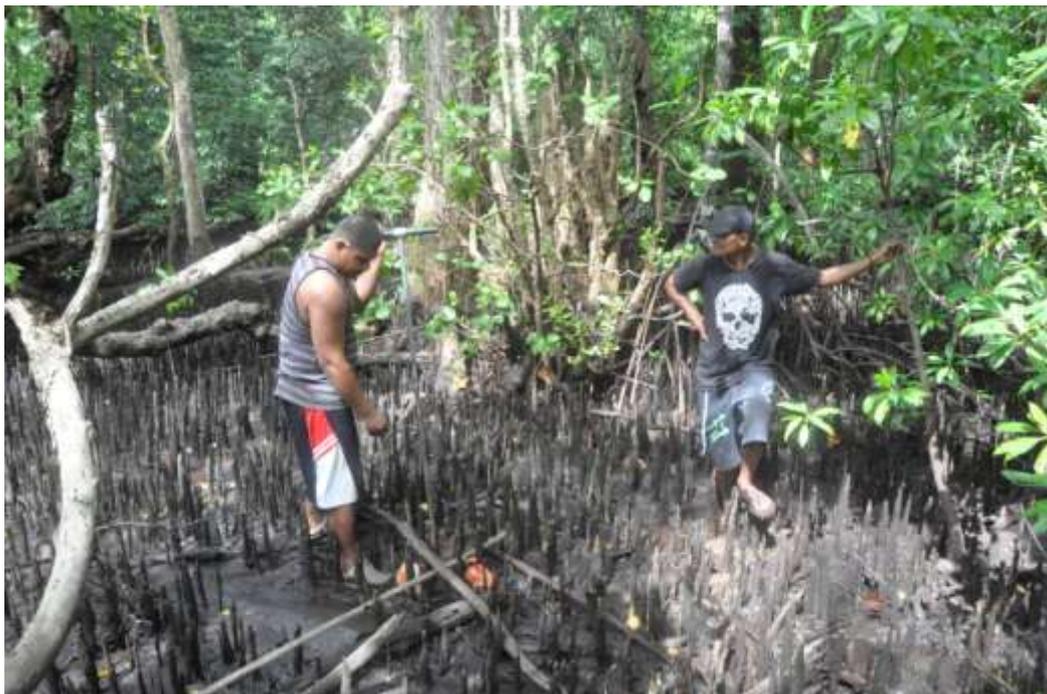
Figure 17. Coring of excavation 5 underway by Motoichi Hebel near platform 84, which reached the depth of 130cm.

Core positioned about 3 meters from the north-eastern wall of platform 84, nearly 8 meters from its eastern corner, in alignment with the large tree growing on nearby platform 99 (fig. 17). The following stratigraphy was observed (fig. 18):

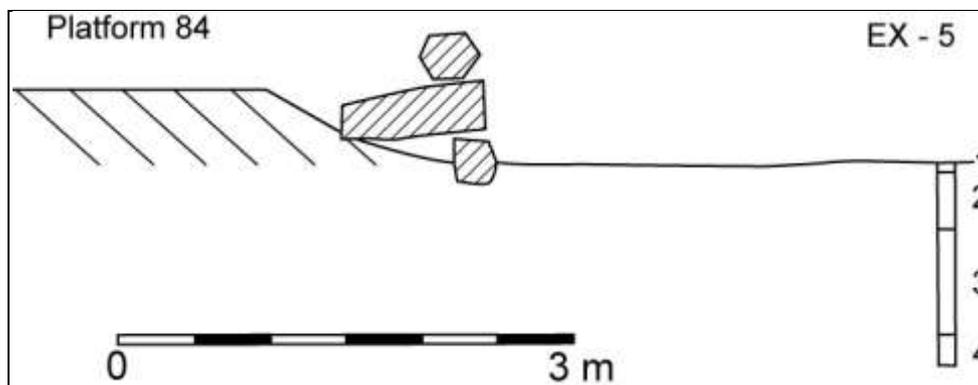
Figure 18. Profile of excavation 5 near platform 84.

- 0-5cm (Level 1). Dark brown soil resulting from decomposing leaves.
- 5-40cm (Level 2). Brown sediment with numerous small to medium-sized stone pebbles<sup>3</sup> (sample collected).
- 40-110cm (Level 3). Clear brown soil mixed with sand, filled with shell fragments, small coral and stone pebbles (sample collected).
- 110cm+ (Level 4). Gray silt/sandy fill with small shell fragments. The excavation was stopped at 130cm deep (sample collected).

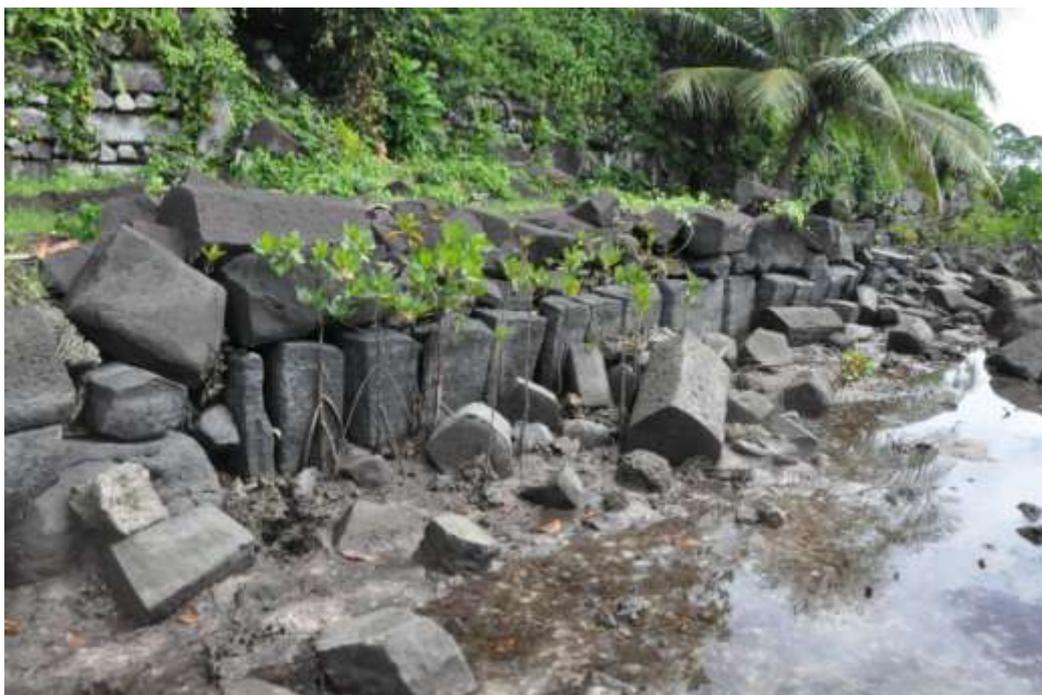
Figure 19. The row of vertical stones in front of the entrance door in the southern wall of Nan Dawas.

Excavation positioned along the southern retaining wall of Nan Dawas platform, facing the lateral entrance to the inner compound enclosing the burial chambers. The choice of the location was directly linked to the unique building layout present for this part of the wall, with the positioning of the trapezoidal stones in a vertical position (fig. 19). Mapping of this portion of the retaining wall counted a total of 20 vertical facing slabs (fig. 20). On its south-eastern corner, a new row of vertical stones facing east can be identified at 90° angle, possibly marking the start of a buried retaining wall going towards the south outer wall of Nan Dawas.

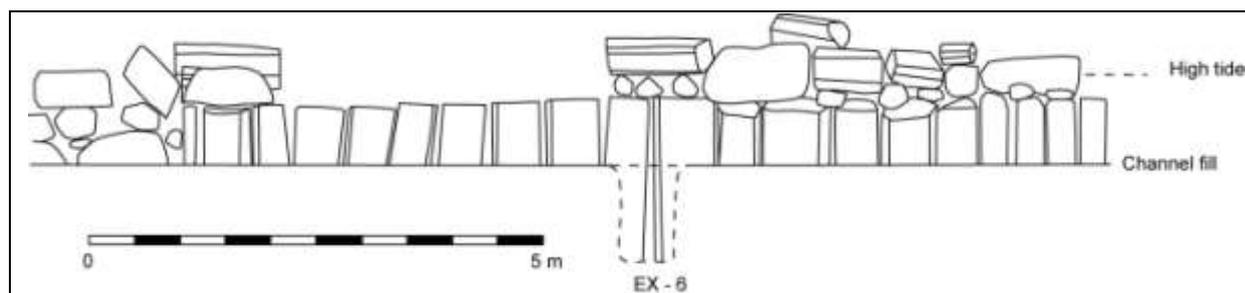
Figure 20. Profile of the section of the southern retaining wall of Nan Dawas characterized by vertical trapezoidal stones. The result of excavation 6 is included in the figure.

The test-pit was located 34m from the south-west corner of the platform, positioned in the only area where two rows of stones top the vertical slabs, possible testimony of minimal erosion. It was hoped that the vertical stones would exceed the length of the retaining wall itself, the basis of the stones having possibly been sealed in the sand to prevent tilting. A number of large stones are present in the mud/sand around the test-pit location. Removal of sediment was done at medium tide, in the water. All sediments were wet-screened through a 5mm mesh (fig. 21). The largest amount of remains was composed of stone and coral pebbles

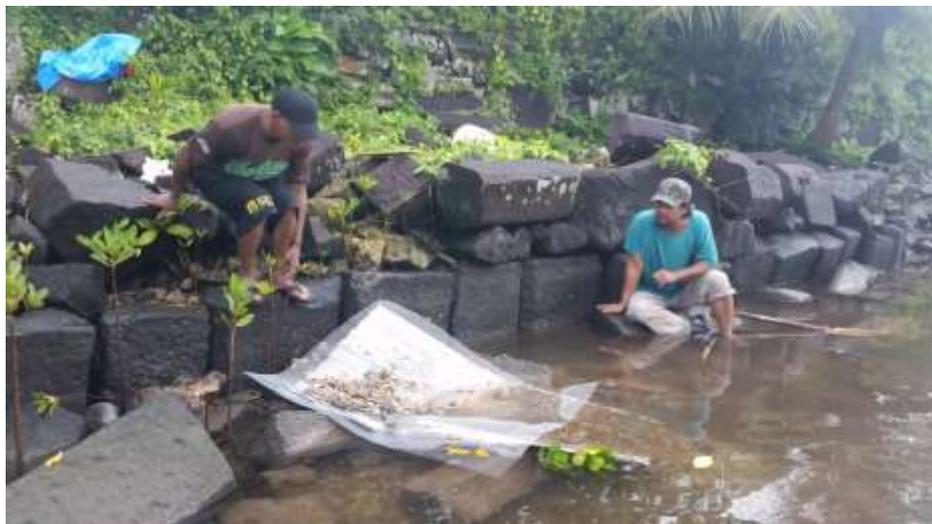
Figure 21. End of the first day of excavation 6, showing the test-pit filled by the incoming tide and sediments after wet screening.

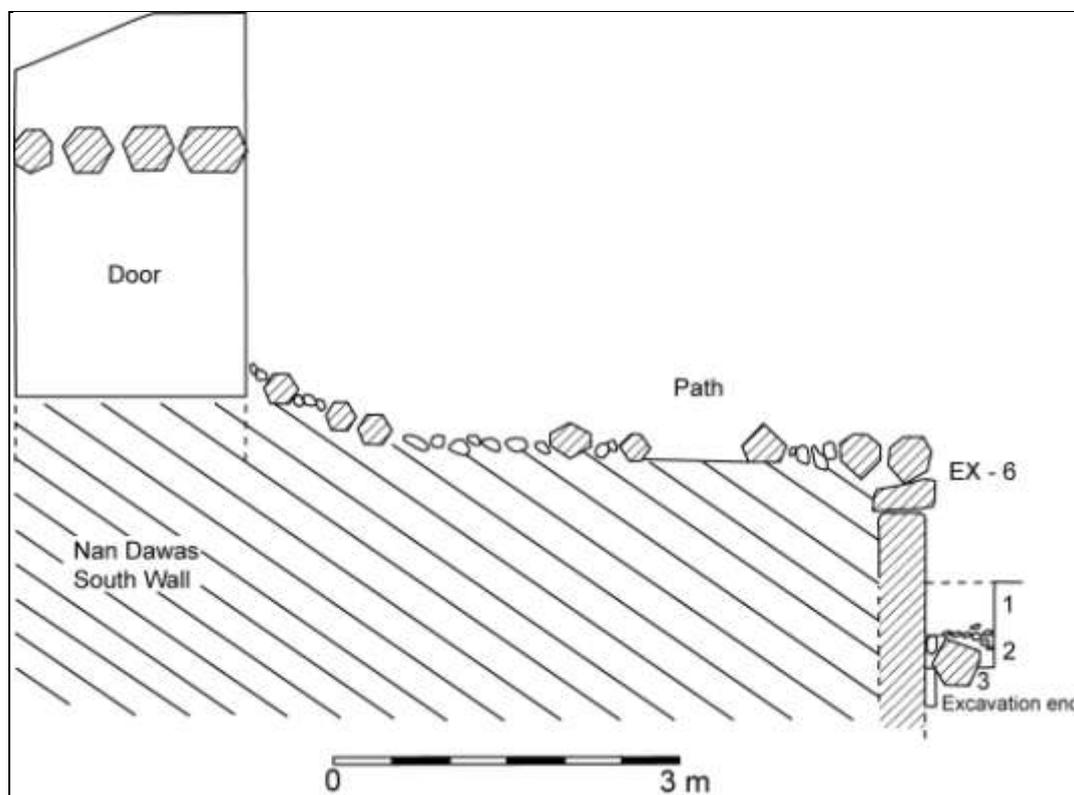
Figure 22. Profile of excavation 6 along the southern retaining wall of Nan Dawas. The outer wall of the burial compound and the collapsed entrance door facing the excavated area have been included in the profile but the detail of each stone has not been drawn due to time constraints.

By observing the sediment screened during the excavation process (fig. 23), it has been possible to infer three main stratigraphic horizons, with height recorded from the top of the fill (fig. 22):

- 0-35cm. Sand with pockets of silt soil (Level 1). Shells are present from the immediate top of the fill, some bivalves (*Pinctada*) being of large size. The rest of the fill is composed of coral blocs/pebbles and of stones fragmented by burning, some up to flake size, as well as archaeological items detailed below. The only modern object present was a blue color plastic rope fragment. Although this has been constantly looked for, no glass fragment has been retrieved from the sieve.

- 35-55cm. Same general sediment fill of sand and silt soil, but with an increase of coral and stone pebbles. Of notice is the presence of a whitish rust on the majority of the pebbles, possibly indicating a long stay in the water.

- 55-80cm. At 55cm depth, the excavation identified in contact with the vertical blocs, what was first thought to be a row of rounded coral boulders running parallel to the retaining wall, but which turned out to be only part of the fill. Outwards from the wall, at about 10cm distance, a polygonal slab positioned parallel to the wall is present. The column is about 45cm thick. The fill of this horizon is more sandy (Level 2), with a larger concentration of stone pebbles and coral pebbles/slabs, possibly indicating a difference in fill process compared to the upper horizons. Shells are present in quantity, as well as some stones. A possible charcoal was identified in the fill recovered at 80cm deep and was collected. It has not been possible to confirm if the horizontal slab is a purposeful arrangement to create a step or is just a fallen rock from the upper part of the wall setting.

- 80-105cm. The space between the vertical stones and the horizontal slab has been excavated to a depth of 105cm. The sediment is composed of a coarse sand fill (Level 3), enclosing only some stone and coral pebbles, a larger quantity of shells as well as some archaeological material (fish bone). The bottom of the vertical slabs was not reached.

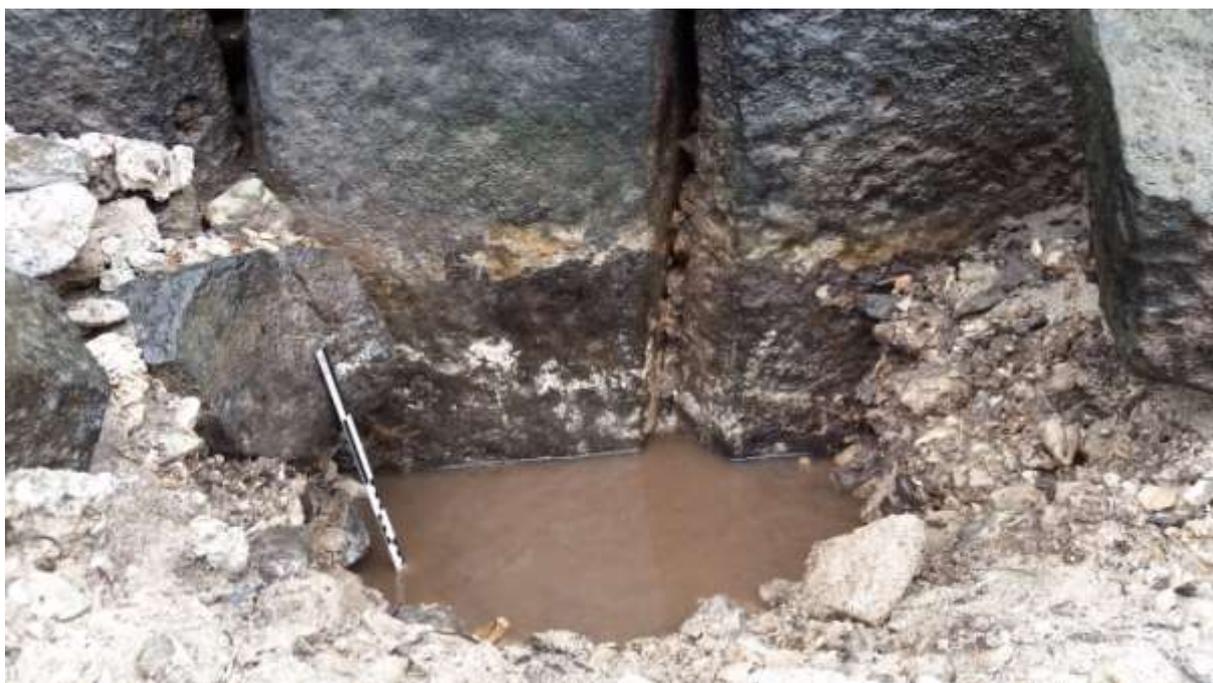
Figure 23. Test-pit of excavation 6 partly filled with water at low tide, showing the numerous shells and stone pebbles present in the sand matrix.

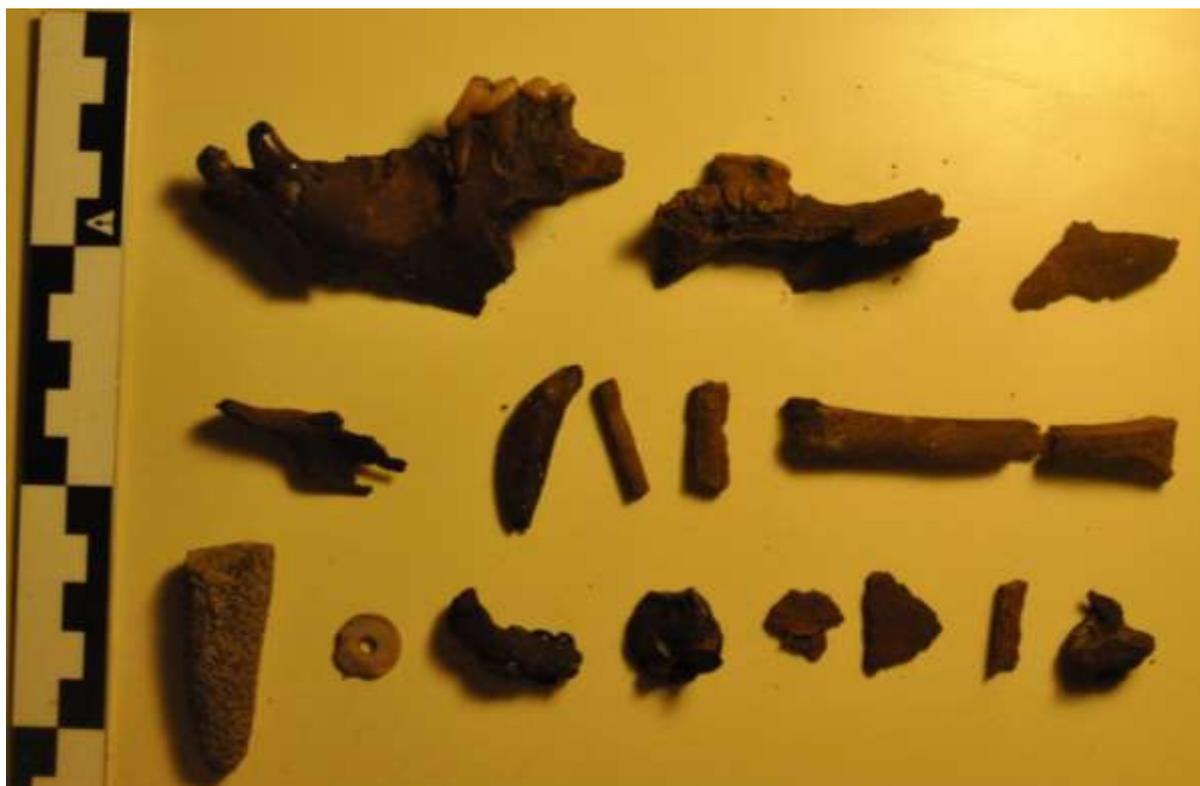
Figure 24. Dog yaw and teeth as well as fish bones and artifacts from the 35-55cm spit of excavation 6.

Table 1 presents the main types of archaeological items retrieved by the wet sieving of the sediments (fig. 24), the photographic inventory of the material being grouped in appendix I. Aside from the shells and the burnt stone pebbles already mentioned, fish bones were present in each spit, some being of significant size. A number of dog bones, especially fragments of yaw and teeth, were also recovered. In layer 1 was discovered a broken fragment of a *Tridacna* adze (fig. 25). A worked piece of oyster shell (possibly *Pinctada*) appears more like a shell-money fragment of the type know in Western Micronesia than a lure (fig. 25). At 50cm deep was recovered a small drilled shell-disk (fig. 26). A possible polished coral file and a reworked oyster shell (knife?) were also identified (fig. 26). The only stone item that was recovered is a polished rounded pebble about 6.5cm in diameter, heavy for its size, possibly used as a hammer-stone (fig. E in appendix I).

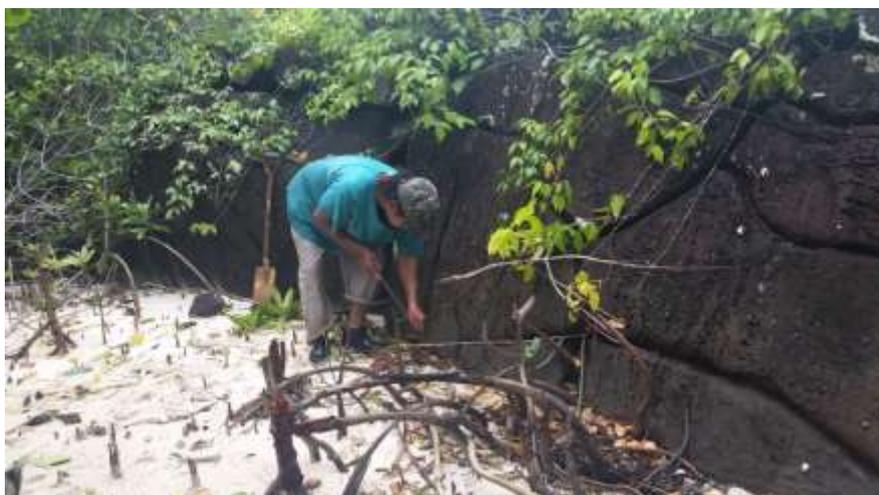
Figure 27. Cleaning of the mangrove overgrowth before the opening of excavation 7 along the south-eastern wall of platform 110.

This excavation was positioned at the south-eastern corner of platform 110 and 20m from the eastern corner making the end of that platform along the channel leading into the Nan Dawas area. The test-pit was positioned at the basis of the outer wall facing the south-east, along the last large stone of the wall, 330cm long (fig. 27). This area has seen accumulation of sand, creating a beach (under erosion at the time of the dig) along about 10m of the wall face, without preventing the growth of mangrove. The scope of the excavation was to locate the basis of the wall.

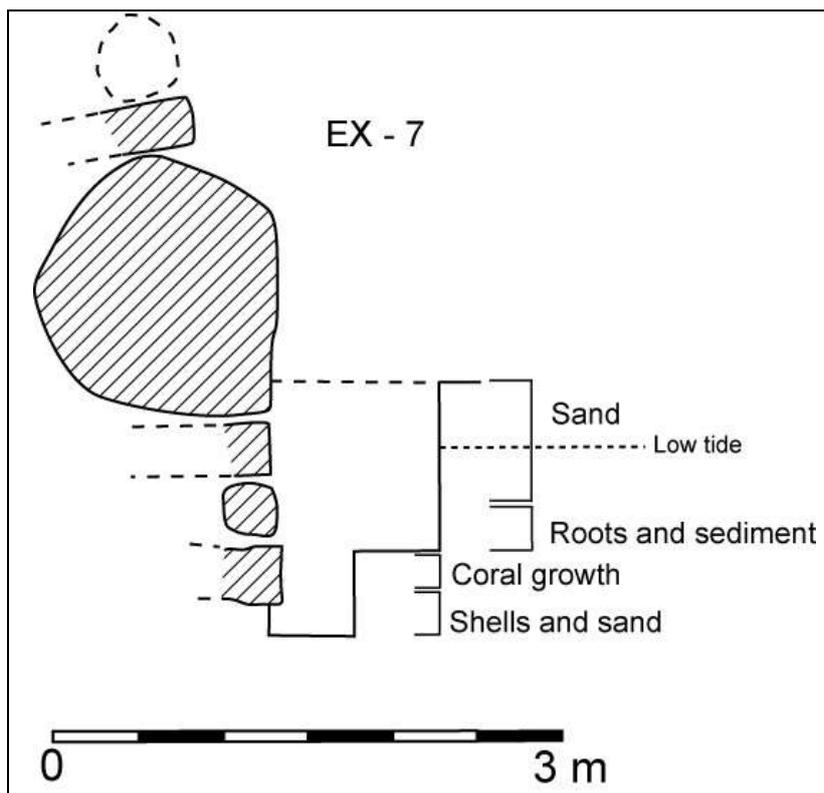
Figure 28. Profile of the filling stones in the central part of excavation 7.

At a first stage of the excavation, a 100cm by 100cm test-pit was positioned along the large stone. The fill being only of natural sand, the excavation was made using a shovel. At 20cm deep in the northern corner of the pit, was identified a large stone placed under the massive upper boulder and expanding about 25cm from the vertical profile of the wall. The downward profile of the upper surface towards the southwest had forced the builders to fill the gap between the end of this large bloc and the boulder, using a trapezoidal slab placed in perpendicular position to the wall, positioned between 25cm and 50cm deep. At this level has been reached the water table and the water had to be bailed out with buckets. A second slab of the same form and placed parallel to the first, ends at the western corner of the pit. These two filling blocs rest on the summit of a large stone placed in the same general vertical alignment to the massive boulder (fig. 28).

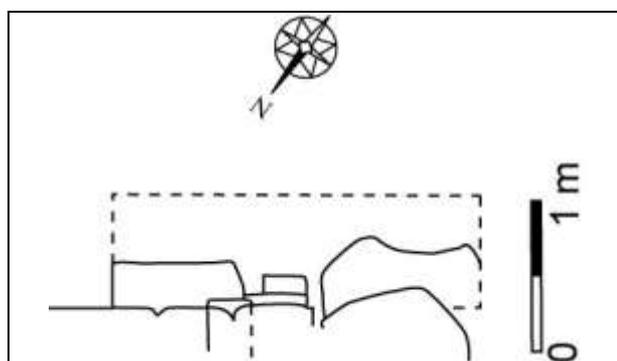
Figure 29. Top view of excavation 7, showing the outward movement of the two largest stones of the lower row.

In order to allow the completion of the excavation, the test-pit was expanded to reach the southern corner of the wall, with a profile of 2.75m. This has allowed to identify the presence of a large rock, at least 120cm long, serving as base for the massive surface boulder forming the corner. This rock has probably moved over time (fig. 29), weakening the support of the boulder, which has broken in two (fig. 30). Due to significant root development along the stones, the excavation concentrated on the central part of the test-pit, leading to the excavation of the lowest stone, which appears at 95cm below the present surface. The fill is composed of dense root mix within a clayish brown soil matrix enclosing some shells. Fragments of a blue glass bottle of unknown age has also been recovered. The 35cm high square basis bloc has definite remains of coral growth on its lower half face. This indicates that at one stage in the past the basis of the wall was exposed to the ocean at all times, allowing coral to fix. The coarse sand matrix on which the wall was built encloses numerous shells.

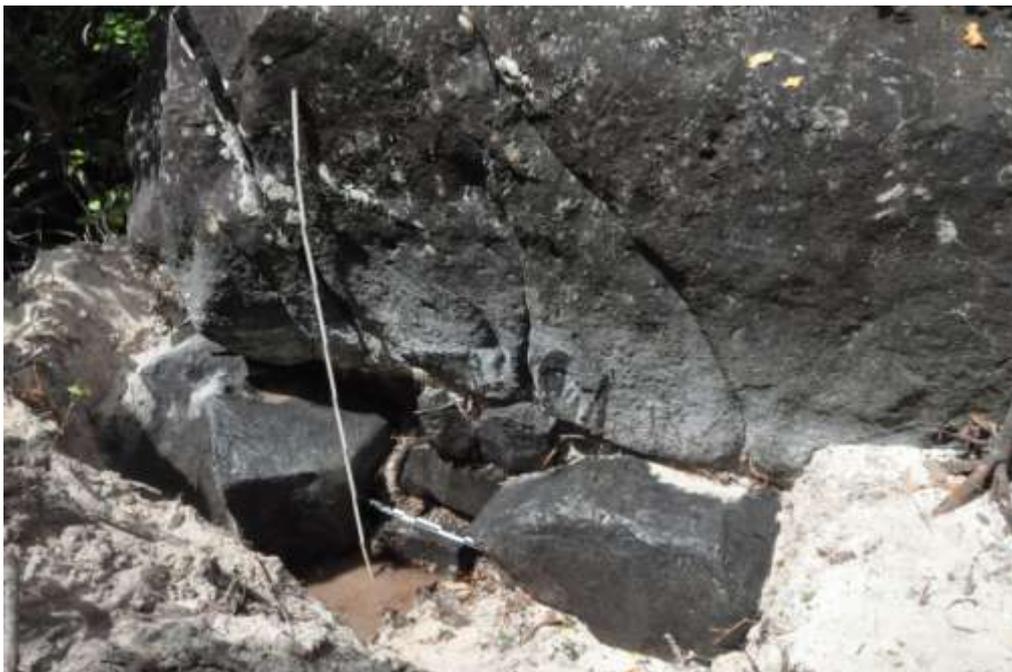
Figure 30. Excavation 7 at the end of the dig, showing the buried cornerstone and the crack in the large top-stone (left of double-meter).

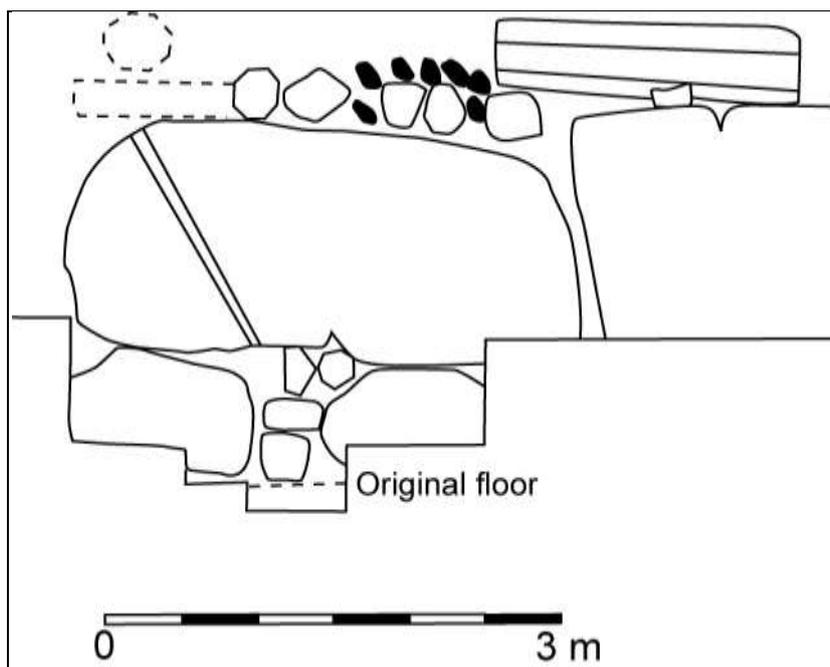
Figure 31. Front view of the corner of platform 110 of excavation pit 7.

The main result of this test-pit has been to demonstrate that the foundation of the wall was only about 85cm below the calculated low tide (the dried mangrove flat in the vicinity) (fig. 31). The lowest row of the southern corner of platform 110 was built with large rocks, exceeding 100cm of length. But clearly, these served mainly as the basis for the massive boulders of the second tier. The total height of this portion of wall was at least 320cm. After building, the wall was exposed during enough time to the open sea, for coral to fix on the lowest stones (see fig. 48). The presence of fragments of a blue glass bottle (with number 6 or 9 printed in the bottom) close to the bottom of the fill (fig. 32), may indicate regular shifting sedimentation and erosion of the sand cays along these exposed outer walls facing the Ocean.

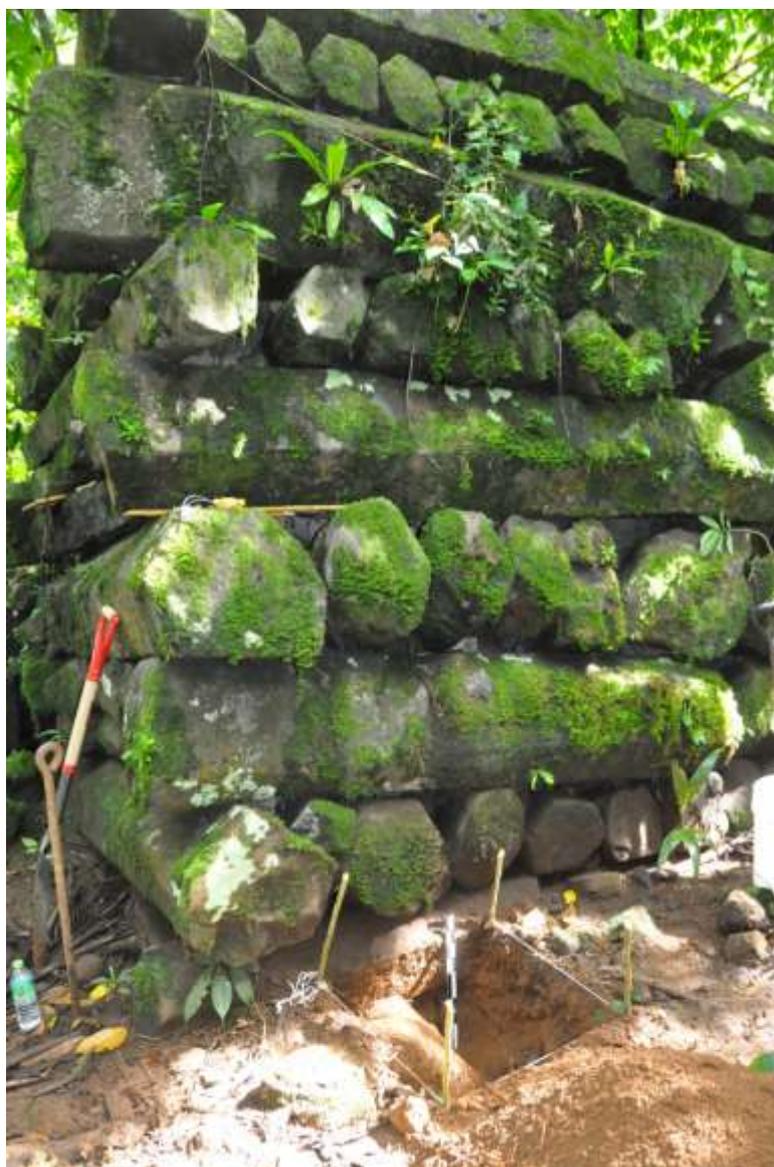
Figure 33. End of excavation 8 along the north-west wall of Peinkitel platform 55, close to the northern corner. The partly buried basis of the lowest monolith is clearly visible.

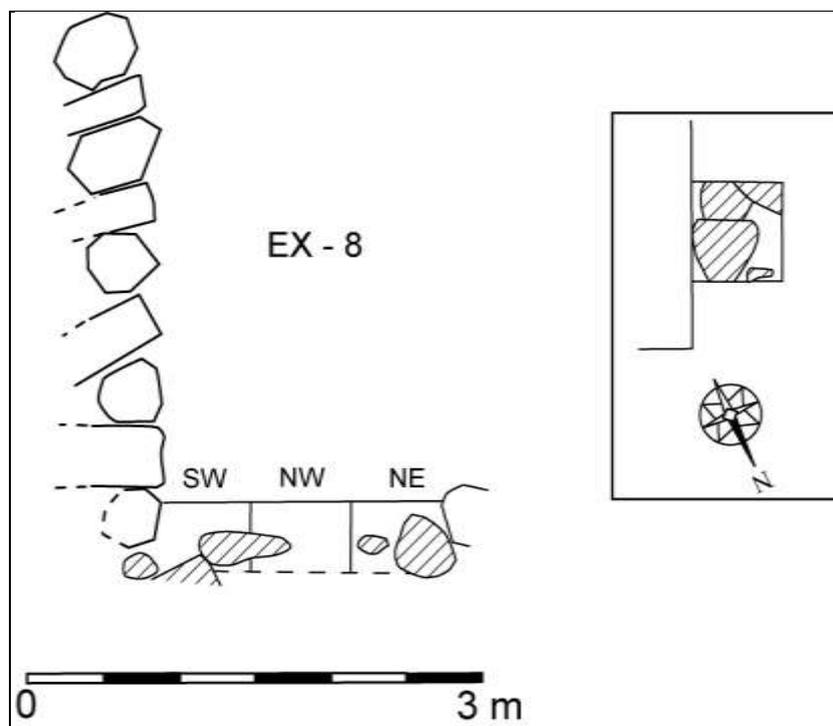
Figure 34. Profile of excavation 8 and position of the different natural blocks identified in the test-pit.

- 0-10cm. Brown clay matrix enclosing numerous stone pebbles of different sizes. Only one small coral slab was identified, at 10cm deep, placed in a flat position. In table 2 are given the sizes and numbers of stones/pebbles for the first 10cm.
- 10-20cm. Same brown clay matrix, with more stone pebbles, which account for nearly half of the fill. Appearance of a large boulder in the eastern corner of the pit, extending both sides over about 20cm.
- 20-30cm. Same matrix with pebbles. The boulder in the eastern corner expands and another boulder appears in the western corner.

- 30-35cm. Same brown clay matrix but with significantly less pebbles. A third boulder appears in the south-western profile. The basis of the wall's large lower polygonal column was reached at 35cm.
- 35-40cm. The brown clay matrix is of finer texture and with little presence of pebbles. A stone bloc appears under the basis of the wall, but without being in contact with the column. A charcoal was present at 40cm, under the wall, and was sampled for possible dating.
- 40-45cm. The three main blocs continue to expand without indicating the presence of their base. They appear to be natural formations. No other stone has been identified under the wall. The soft soil with few pebbles form the matrix around them. The excavation was stopped at 45cm deep.
