**Looking for the basis of Nan Madol's  
platforms: coring and test-pit excavations  
in some channels and structures of  
Pohnpei's World Heritage Property  
(Federated States of Micronesia) (23<sup>rd</sup>  
January-3<sup>rd</sup> February 2018)**

**SAND, Christophe  
LEBEHN, Jason  
SILBANUZ, Semens  
WALTER, Peter Salapat  
BARNABAS, Jason  
HEBEL, Motoichi**

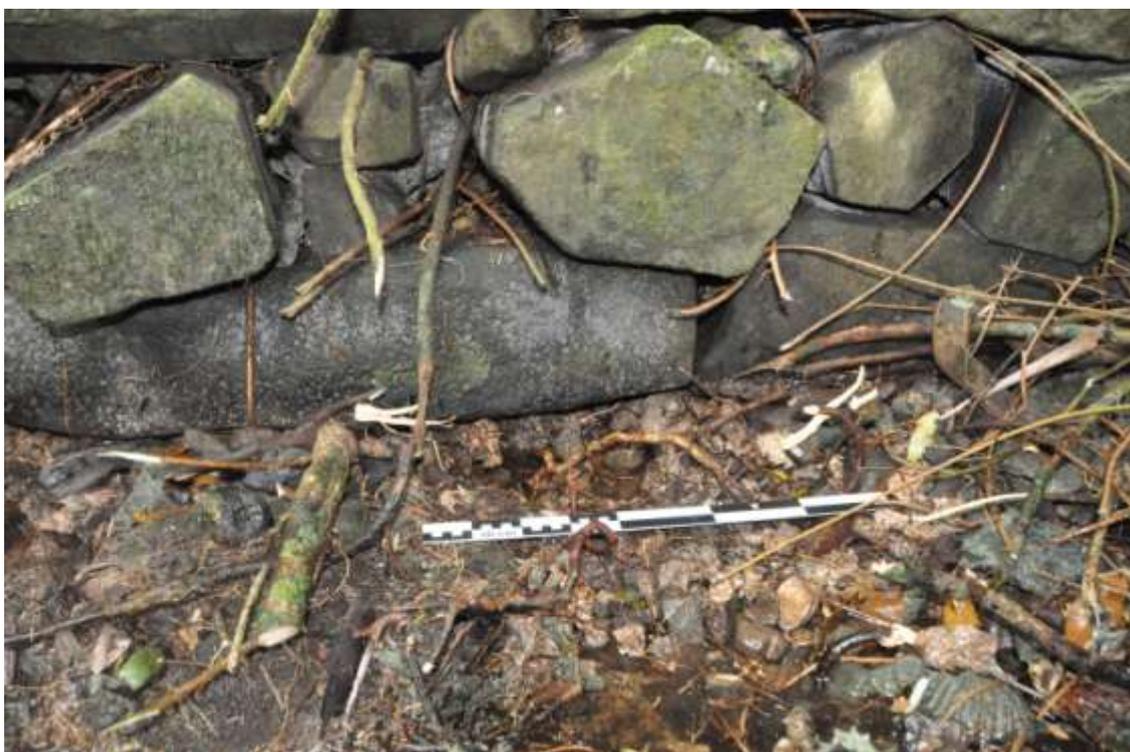
Figure 35. View of the coral fill underneath the lowest row of stones of the wall separating platforms 103 and 104.

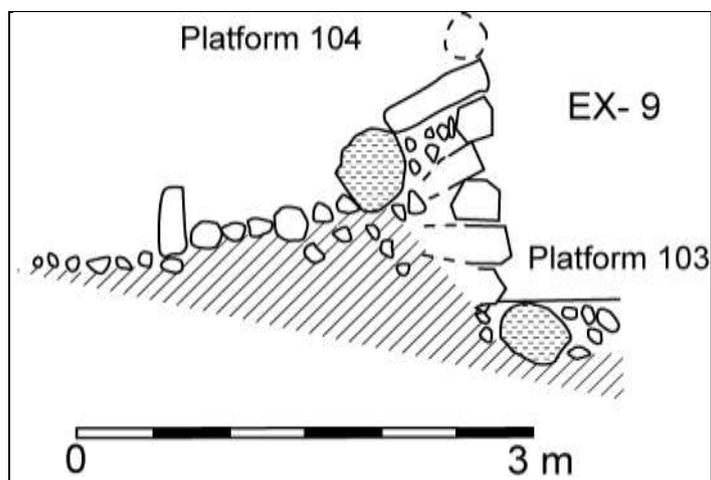
Figure 36. Schematic profile of the outer wall of platform 104 and excavation 9 on platform 103, illustrating the absence of downwards building of the wall.

A test-pit was positioned at about 3 meters of the south-east corner of the retaining wall of platform 104 (Usendau), the excavation being done in the fill of platform 103 (Pahseid). Platform 103 has been interpreted in some studies as an adding to the older platform 104, and it was though hoped that the original southern retaining wall could be followed along the fill. After removal of the upper stratum of small coral pebbles, it appeared that the lower polygonal boulders were in fact the basis of the retaining wall (fig. 35). These had been positioned on a fill of small and large coral boulders, some exceeding 50cm in

diameter (fig. 36). It is though difficult to demonstrate that the two platforms were built at different times. If this was indeed the case, this excavation indicates that the former retaining wall was removed, possibly to use the stones elsewhere.

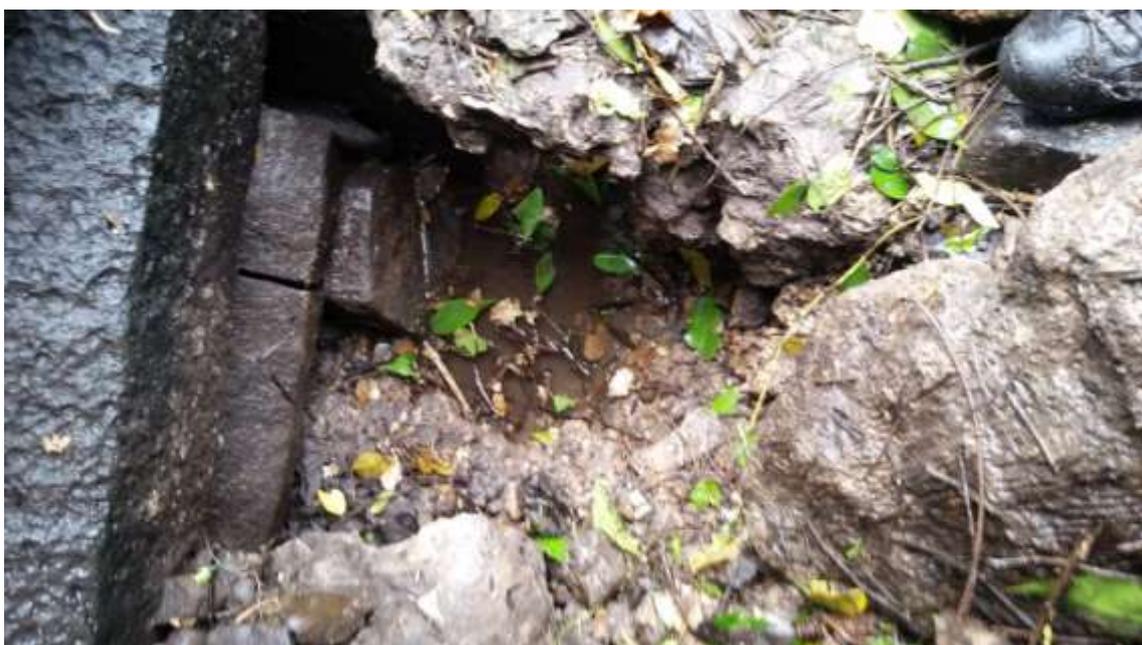
Figure 37. Excavation 10 in progress, showing the boundary between the wall construction and the coral fill in the lower tiers of the wall separating platforms 103 and 104. Note the size of the large coral blocs used for the main fill.

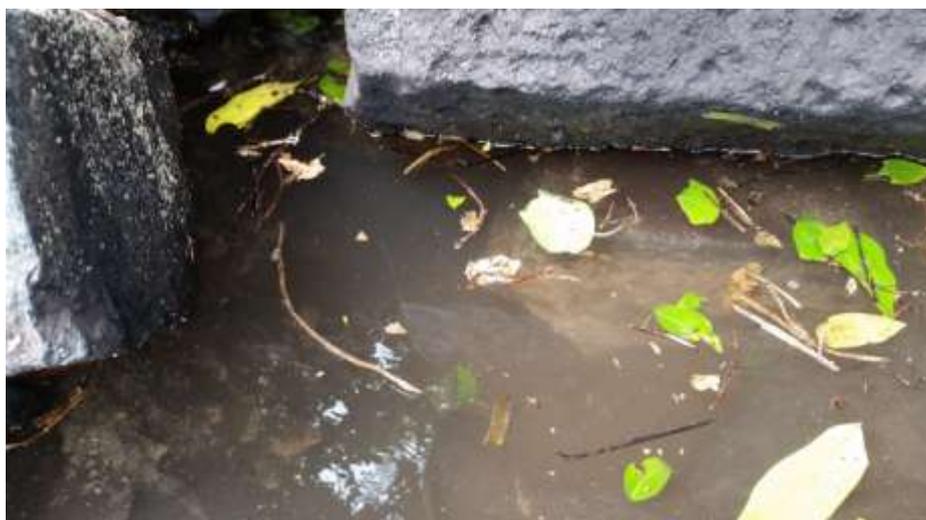
Figure 38. Excavation 11 at rising tide. The lower row of polygonal stones of the southern corner of the retaining wall of platform 104 (facing the main channel) is visible in the water.

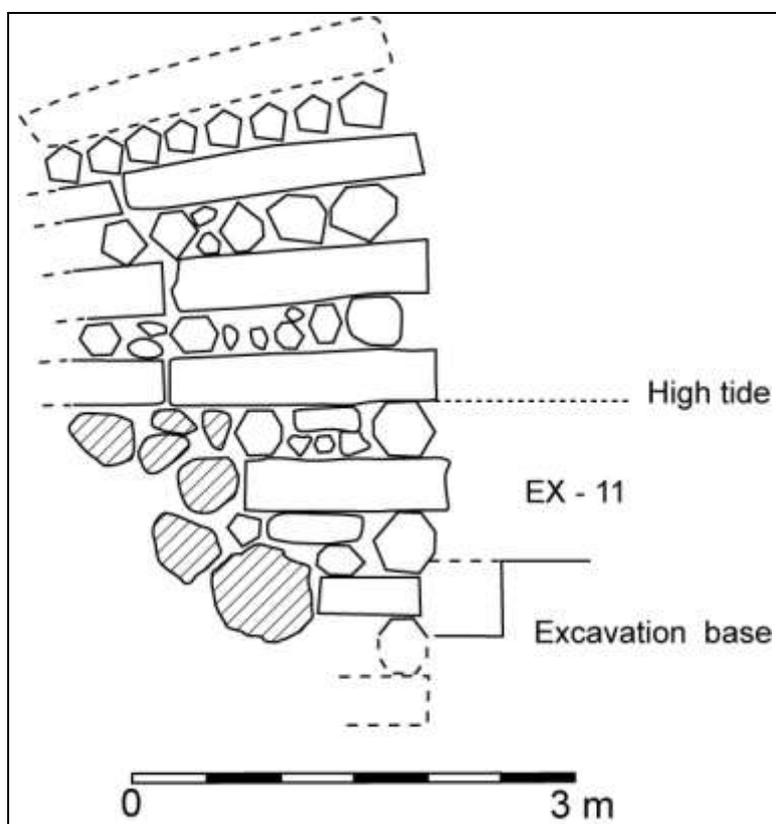
Figure 39. Schematic profile of excavation 11, showing the possible depth of the wall of platform 104 facing the main channel.

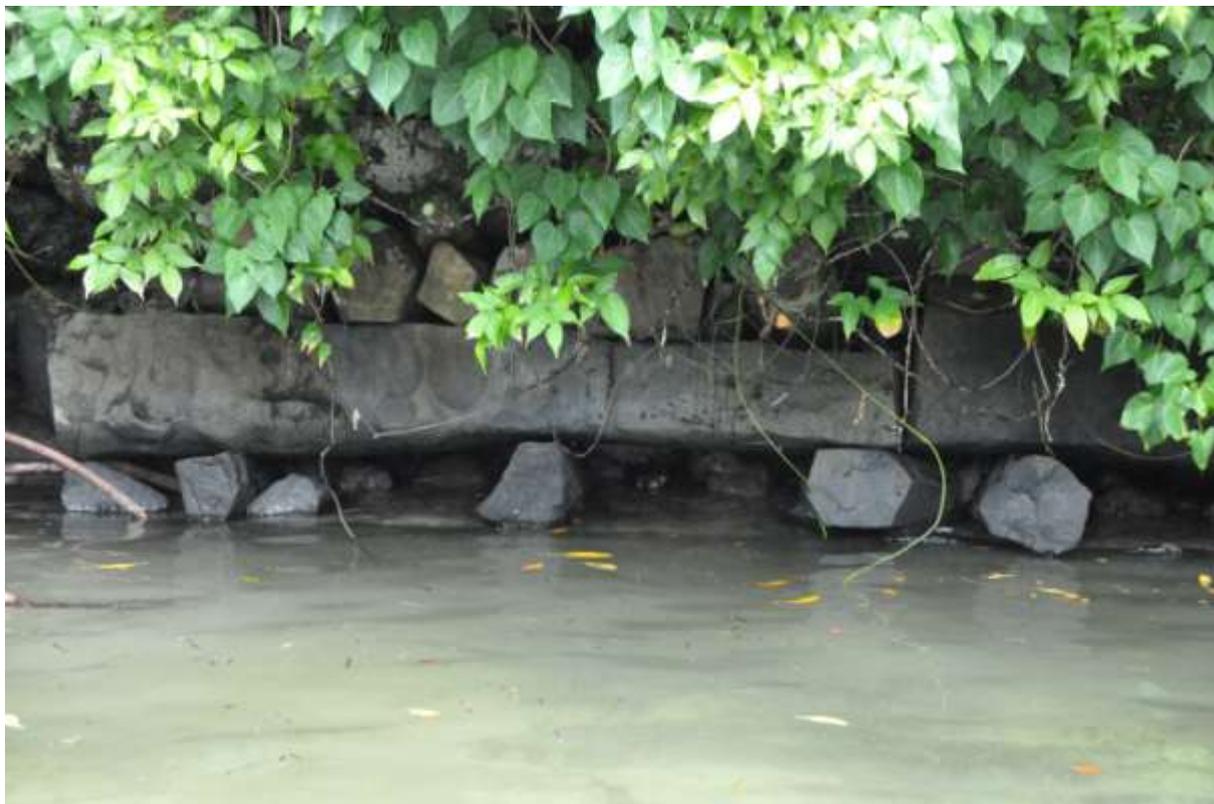
Figure 40. View of the wall area of platform 129 where excavation 12 was positioned.

A small test-pit was positioned along the south-western face of the retaining wall of platform 129 (Lemenkau), facing the “blue hole” in between two of the south-eastern protective wall platform of Nan Madol (fig. 40). The presence of coral growth visible on the outer surface of the lower stones allows to calculate that the basis of this wall is about 50cm under the lowest tide mark, resting directly on the sand fill.

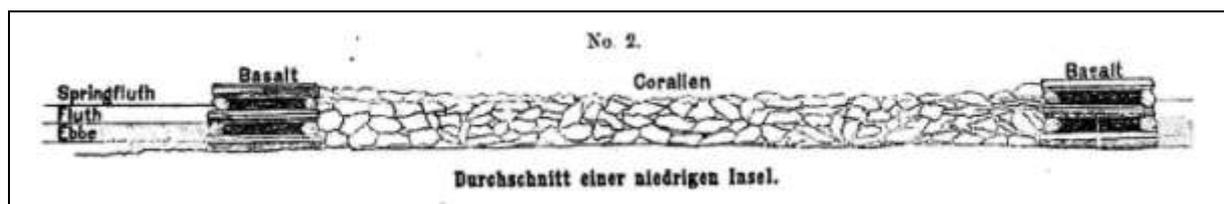
Figure 41. Profile of a low platform of Nan Madol published in Kubary's paper of 1874.

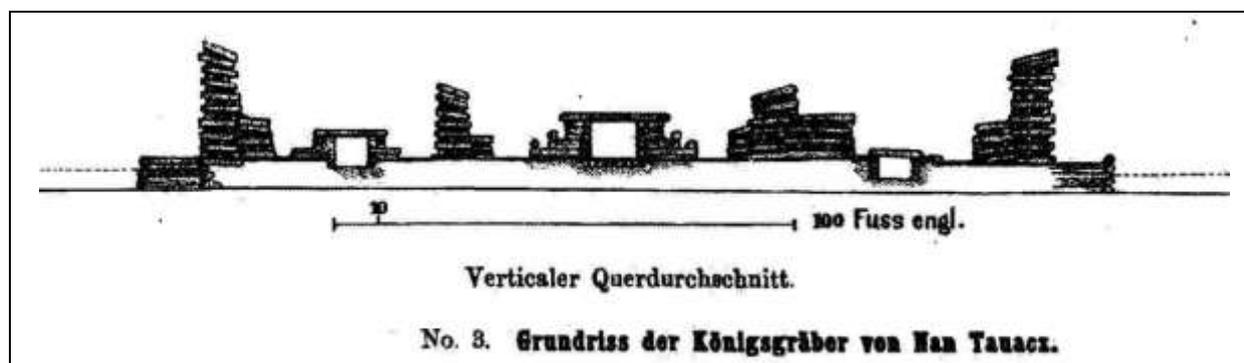
Figure 42. Schematic profile of Nan Dawas, illustrating the basis of the retaining wall placed directly on the original sand floor.

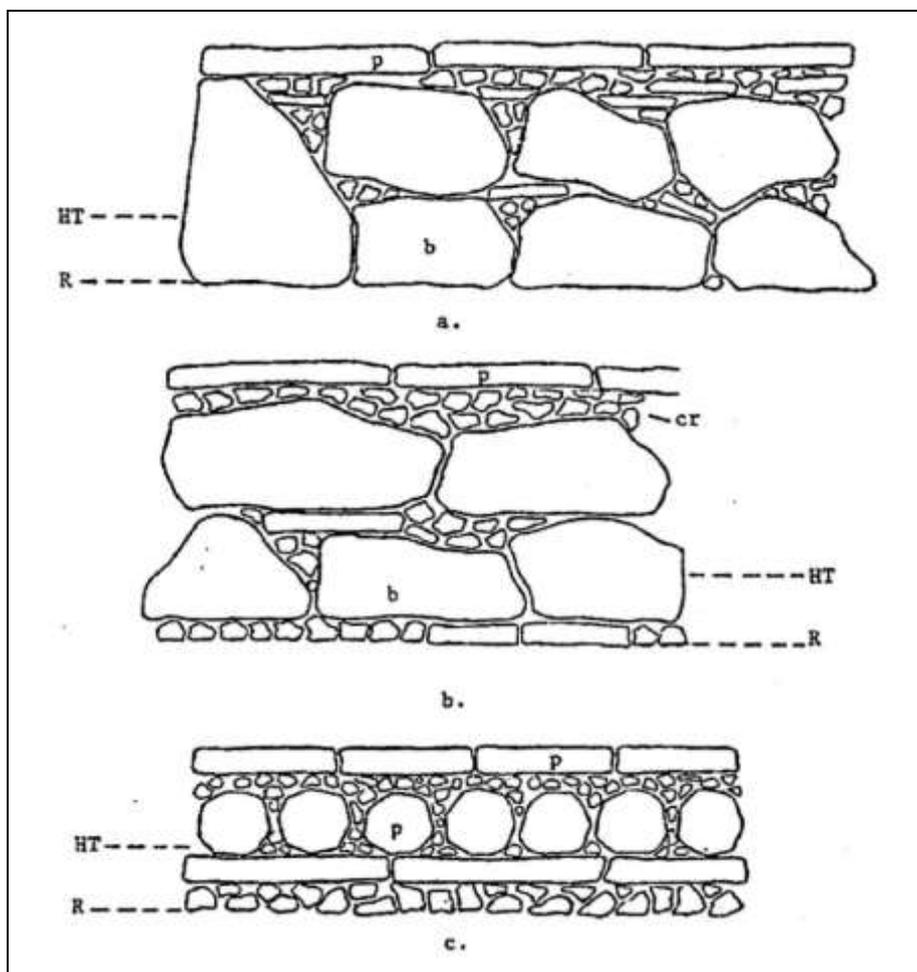
Figure 43. Example of schematic profiles published by P. Hambruch (1936, p. 15-16, in Ayres et al. 1983), showing (HT) high tide height and (R) the estimated reef surface.

In the publication of the German *Südsee Expedition*, P. Hambruch (1936) sketched a series of profiles, drawing platforms basis resting on the reef, understood as being the soil stratum visible during historical times (fig. 43). Japanese archaeologists excavated at Nan Madol between the two World Wars (ex: Yawata 1932; Muranushi 1942), but their publications have not been assessed for the present study and it is not known if they published profiles of the site's platforms.

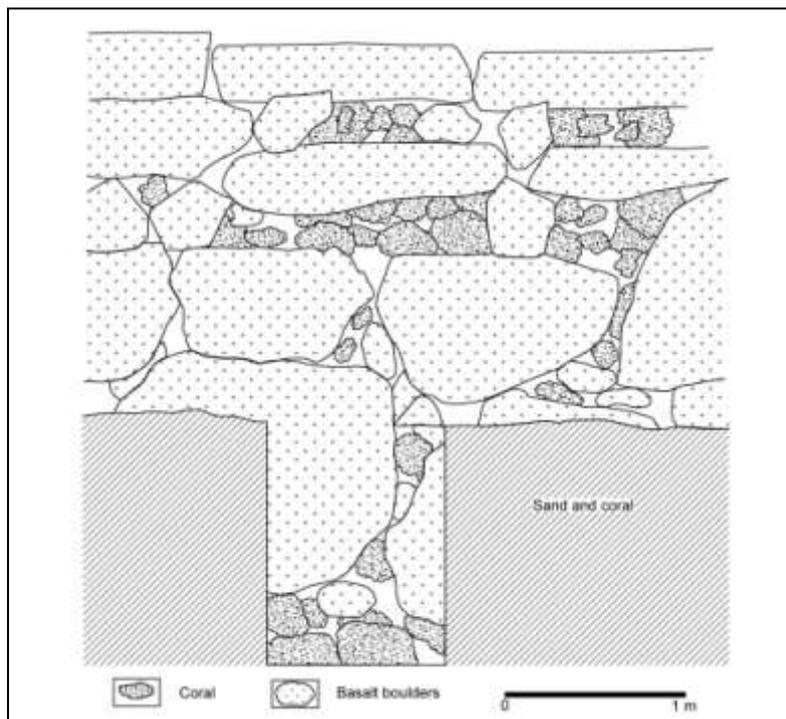
Figure 44. Profile of the excavation between Pahnwi 1 and 2, showing the basis of the outer wall of the platform at the bottom of the excavation pit (redrawn from Ayres 1985, fig. 8).

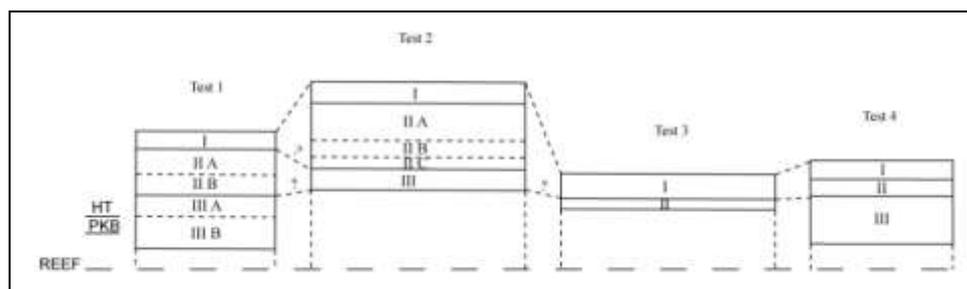
Figure 45. Stratigraphic correlation table for 4 excavation on Pankedira platform 33, with the following labels: "HT marks the high tide mark; PKB notes the outer base of the Pahn Kadira islet wall; and Reef designates the estimated level of the original, pre-construction coral reef flat" (Ayres et al. 1983, p. 127. Redrawn from the original figure).

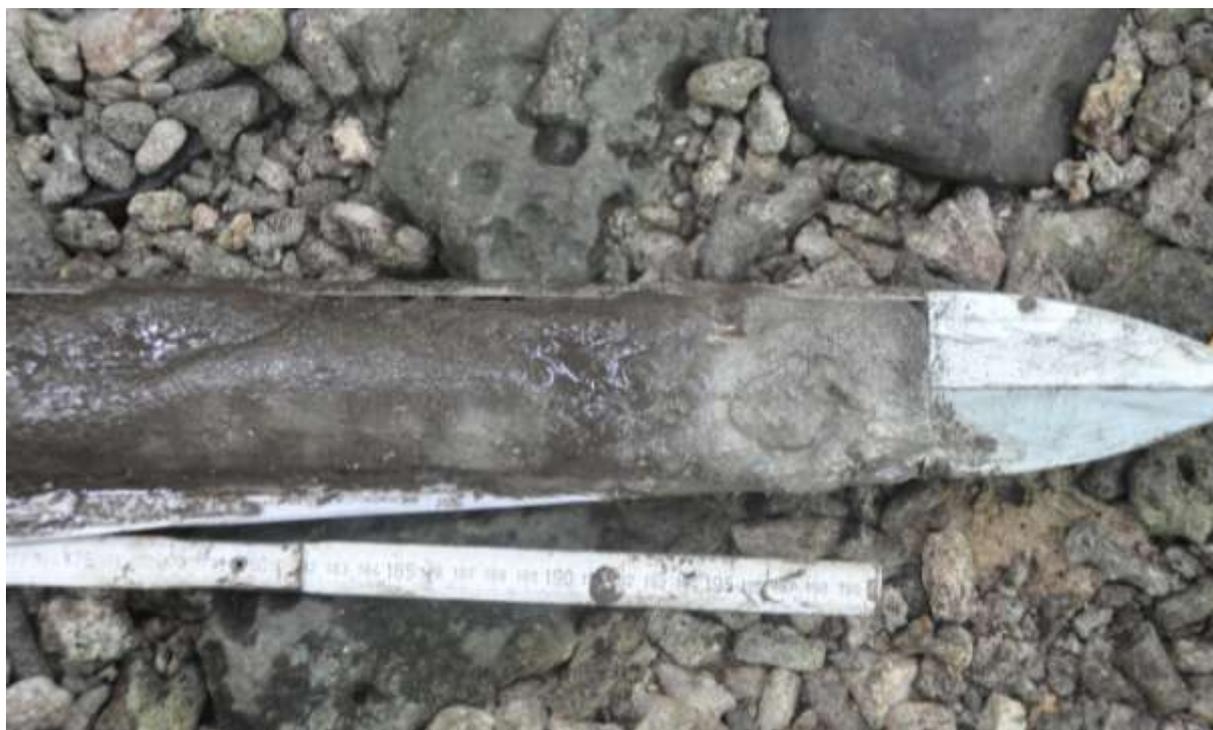
Figure 46. The sandy sediment observable at the bottom of core EX. 3, at about 180cm deep.

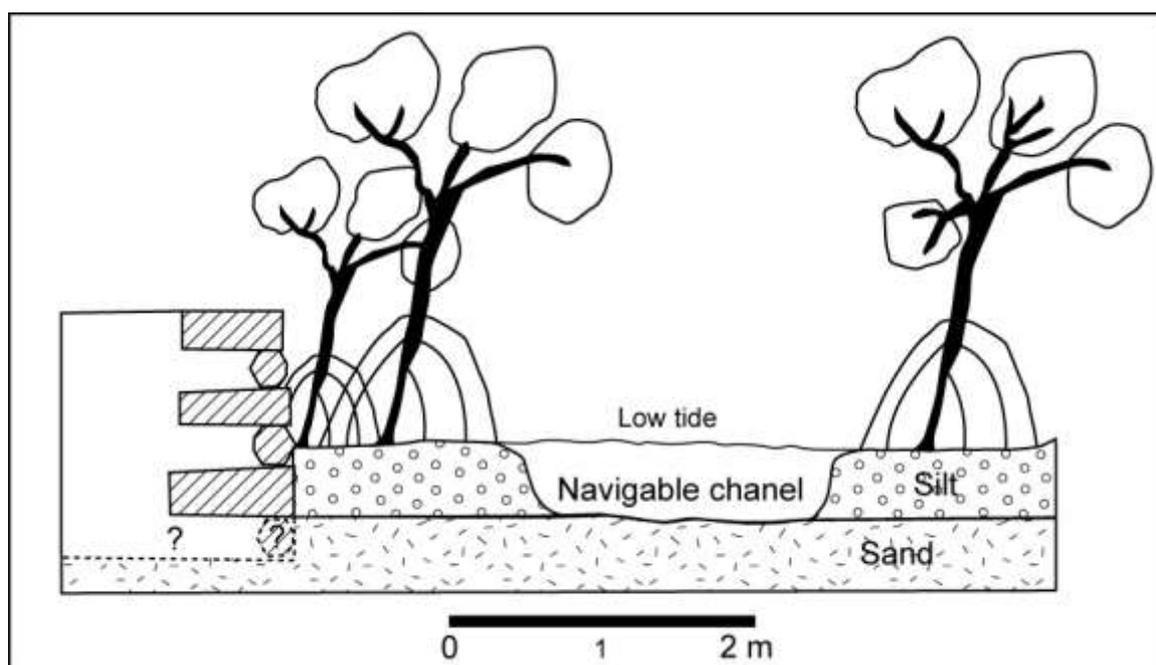
Figure 47. Schematic cross-section of the navigable channel near platform 93, illustrating the stratigraphic separation between the upper silt fill associated to mangrove growth, and the underlying sand layer.

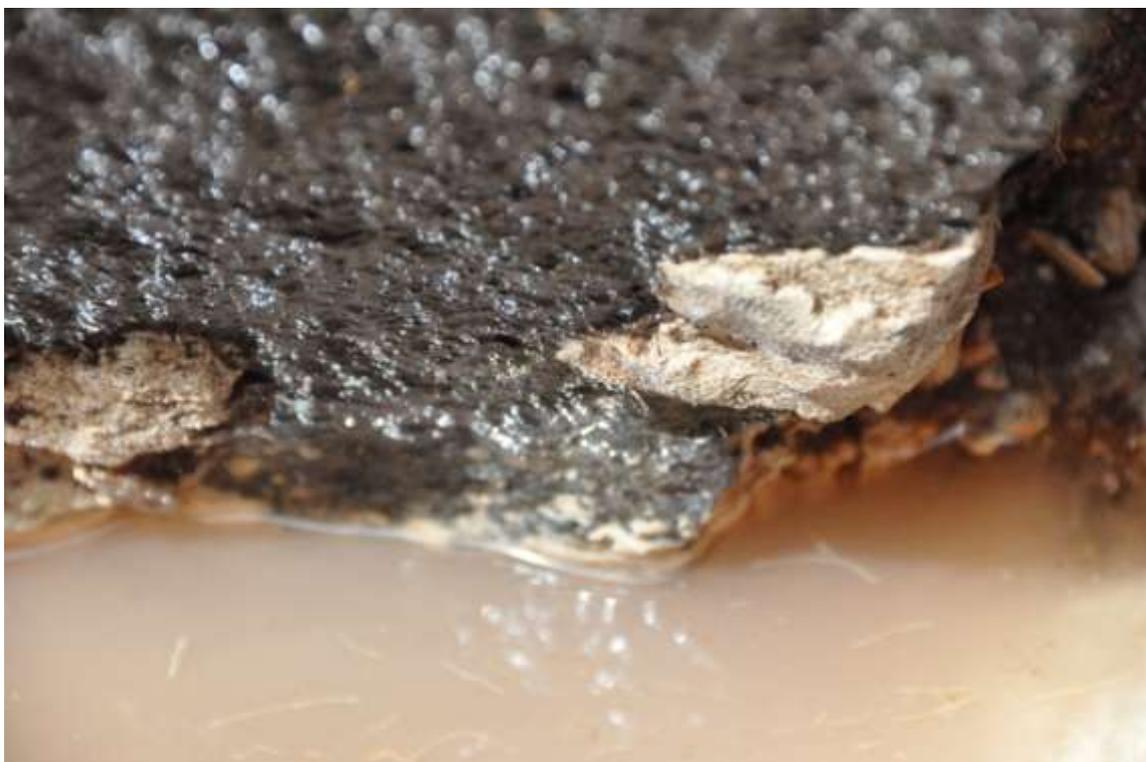
Figure 48. Fossil coral growth on the lowest stone row of the outer wall of platform 110 (excavation 7).

A different setting was observed for excavation EX. 7, along one of the outer protective walls to the south of Nan Dawas (platform 110). The upper fill was mainly of white sand without any significant amount of other remains aside from some large blocks of coral that had eroded out from the wall. The compact roots/soil layer indentified underneath, which enclosed a blue grass bottle basis, was tentatively interpreted as a former mangrove formation. The basis of the wall was reached at about 100cm deep, positioned on a coarse sand layer with crushed shells. At mean low tide during construction, the top of the lowest row of basalt blocks would though have been over water. In this excavation EX. 7 as well as in excavation EX. 12, the lower part of the blocks preserve the remains of coral growth (fig. 48), indicating that after construction the stones where in open water for a long time. The sand cover was though part of a later formation process and the dating of coral samples from the basis of EX. 7 might in the future give some chronological background to this. This data highlight the significant natural process involved in the progressive deposition of sand in the channels over the centuries, mixed with eroding coral fragments from the platforms fill and refuse (burnt cooking pebbles, shells, broken items) thrown into the channels by the site's inhabitants when Nan Madol was occupied. The fill has been constantly reworked and mixed by crab activity, without nevertheless leading to a complete disappearance of stratigraphic differences between layers, as has been identified in excavation EX. 6.

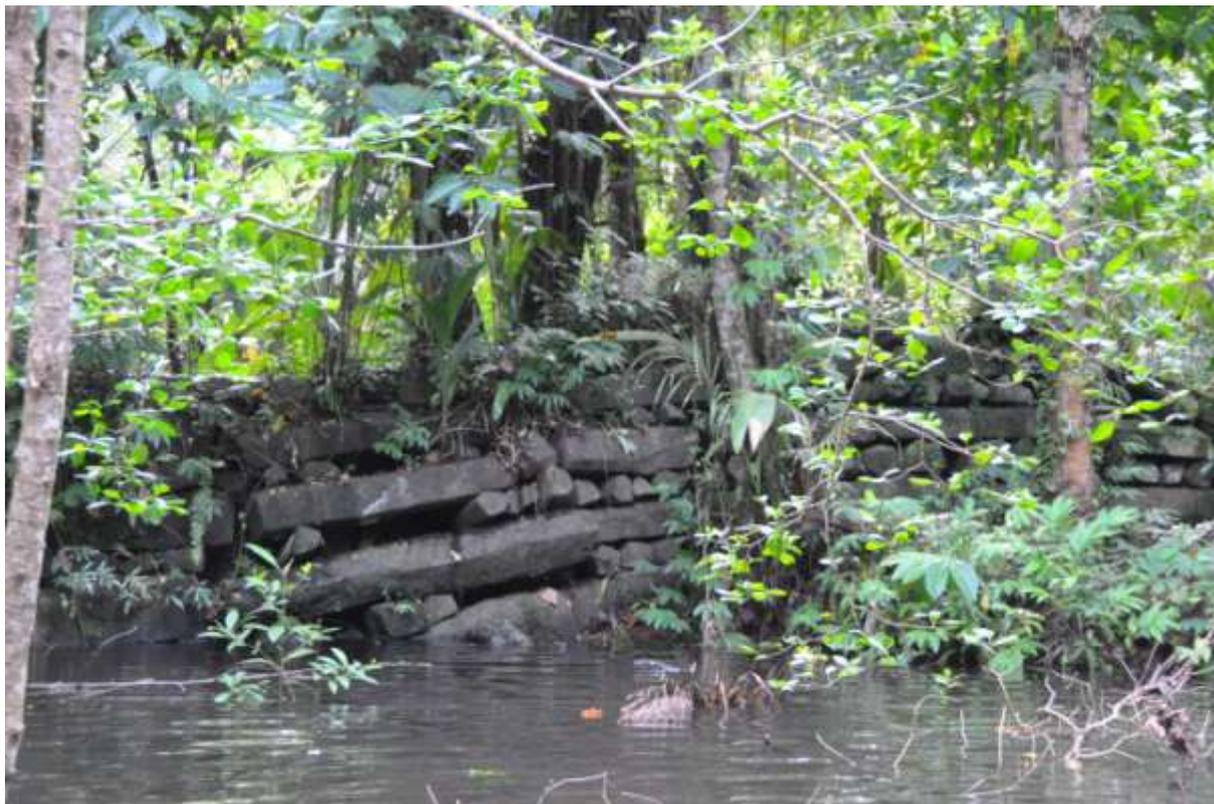
Figure 49. The north-eastern wall of Peinkitel platform 55, showing the tilting of the wall into the marshy soil at the edge between dry and wet land.

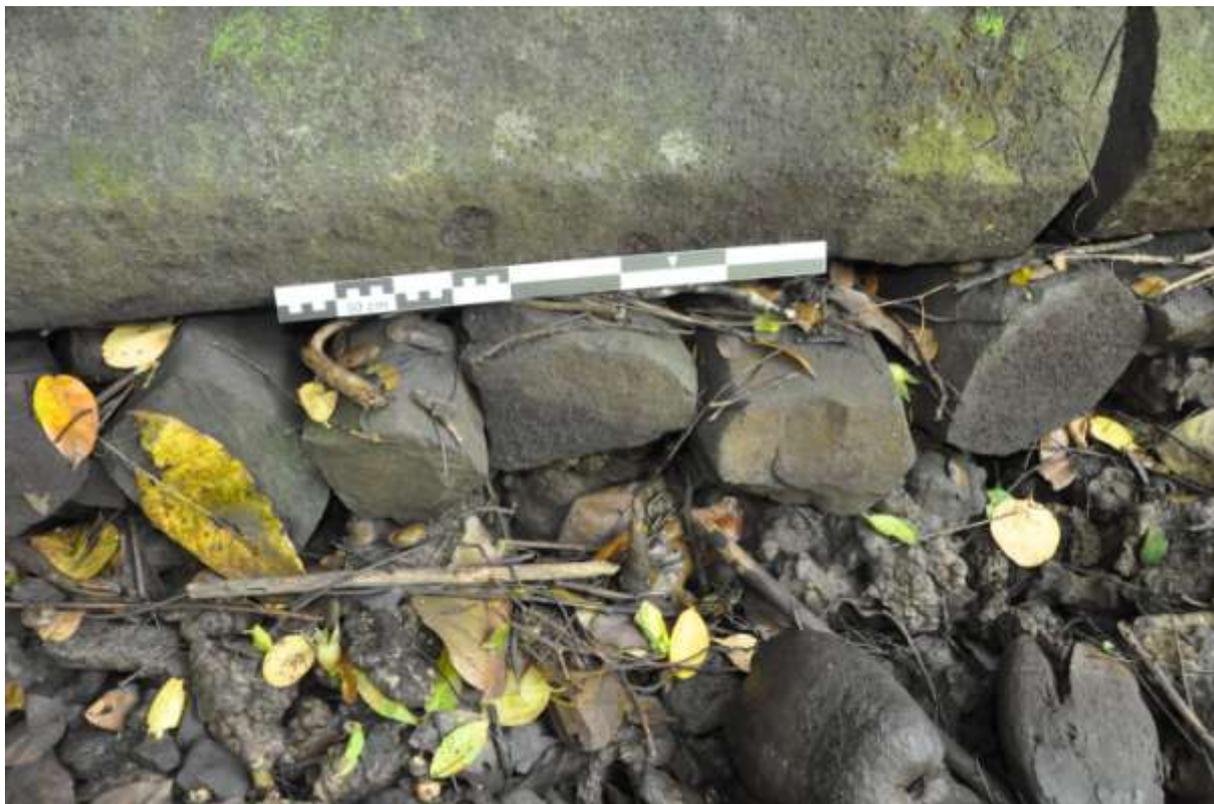
Figure 50. Inner side of the southeastern wall of Peinkitel platform 55, showing the lowest row of polygonal columns placed on a fill of coral boulders.

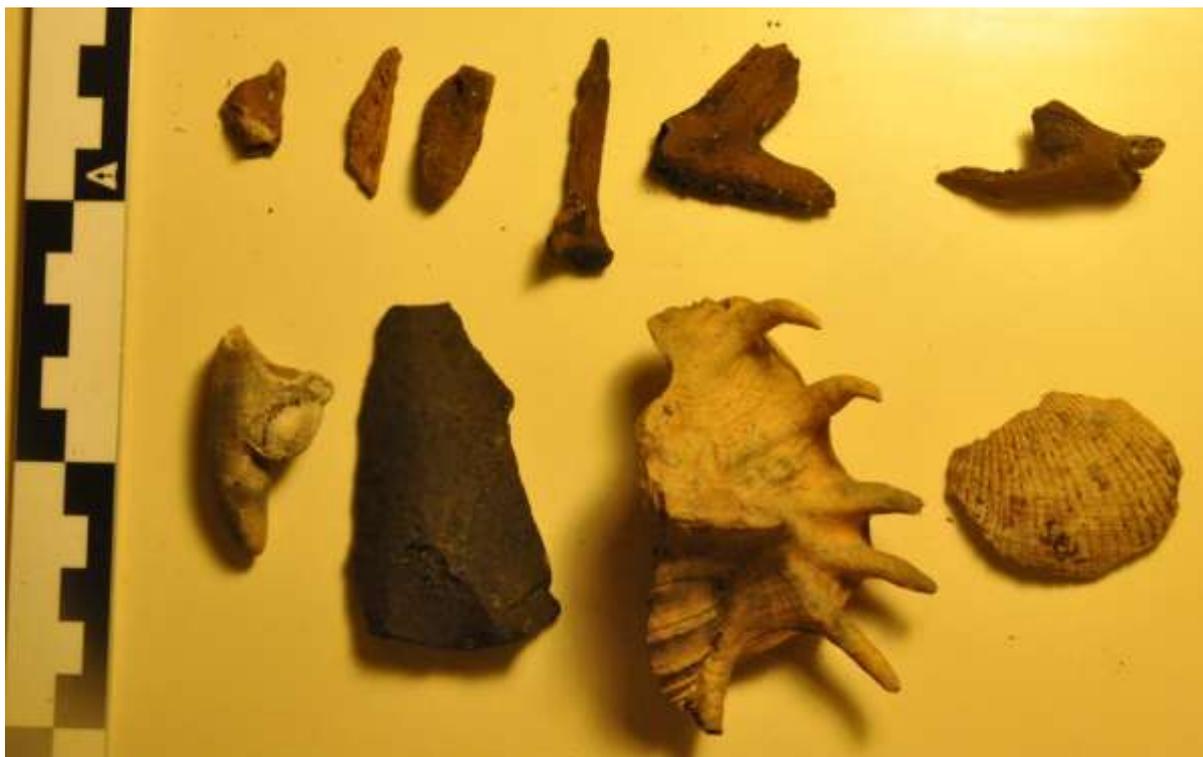
Figure C. Archaeological material from spit 55-80cm.

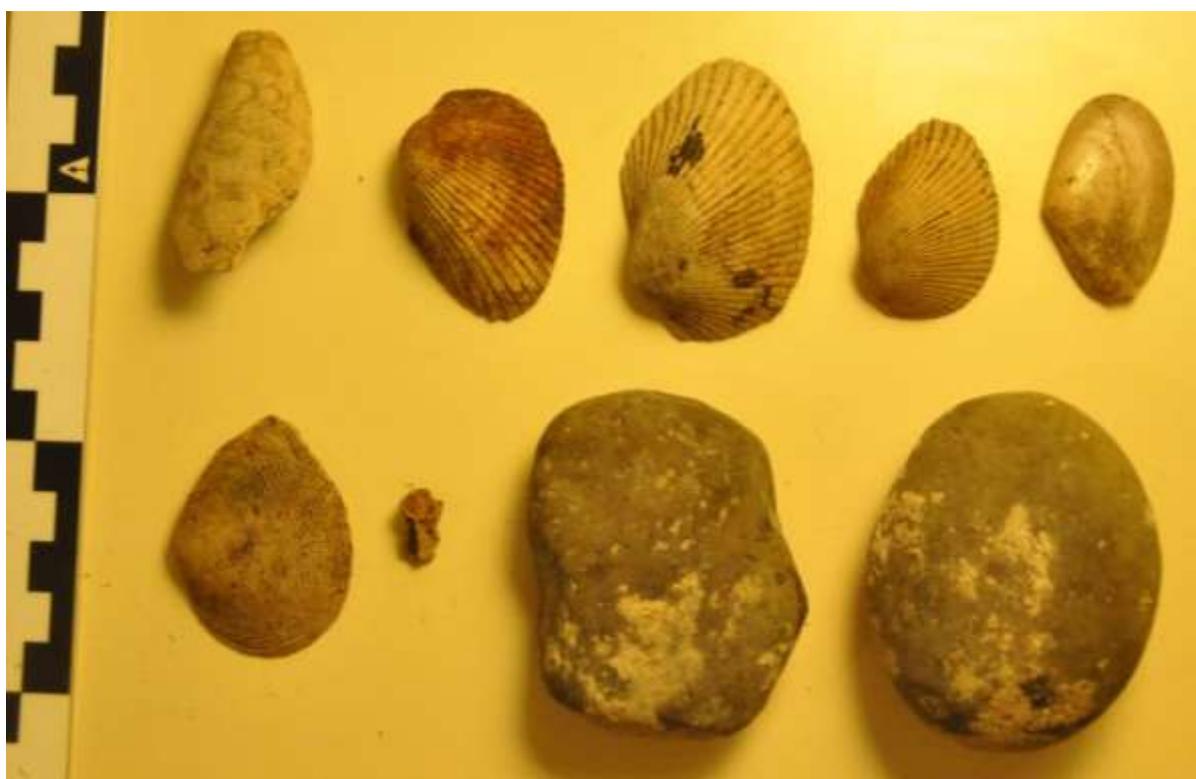
Figure D. Archaeological material from spit 80-100cm.
